2024 Powassan Building Assessments

**TROUT CREEK COMMUNITY CENTRE
181 MAIN STREET WEST, POWASSAN**

Municipality of Powassan

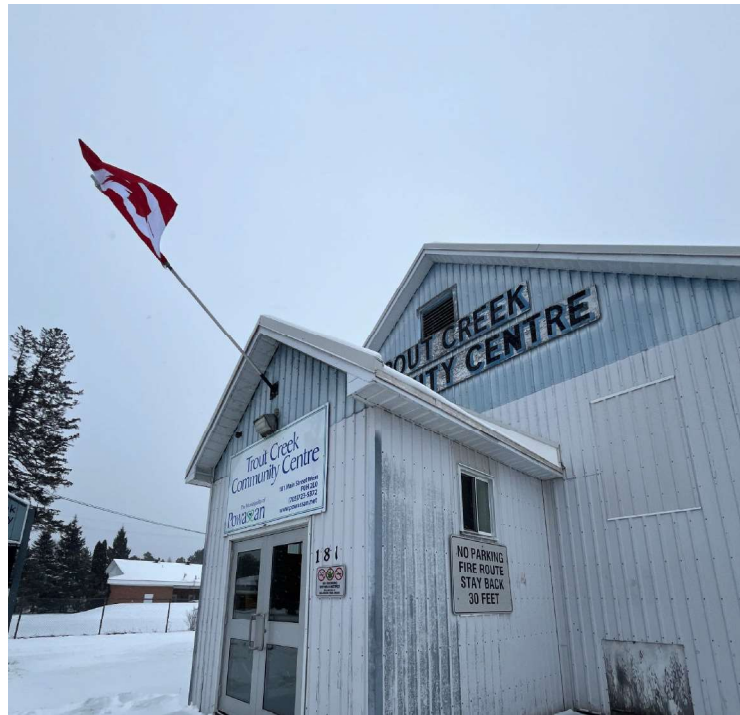
Tatham Engineering Limited (Tatham) was retained to perform a Building Assessment of the Trout Creek Community Center, located at 181 Main Street West in Powassan. We visited the site in April, 2024 and spoke with Public Works Foreman, Trevor Tenant to identify any areas of concern and provide details on operating procedures. An overall photograph of the building has been included as Photograph 1.1 in Appendix A.

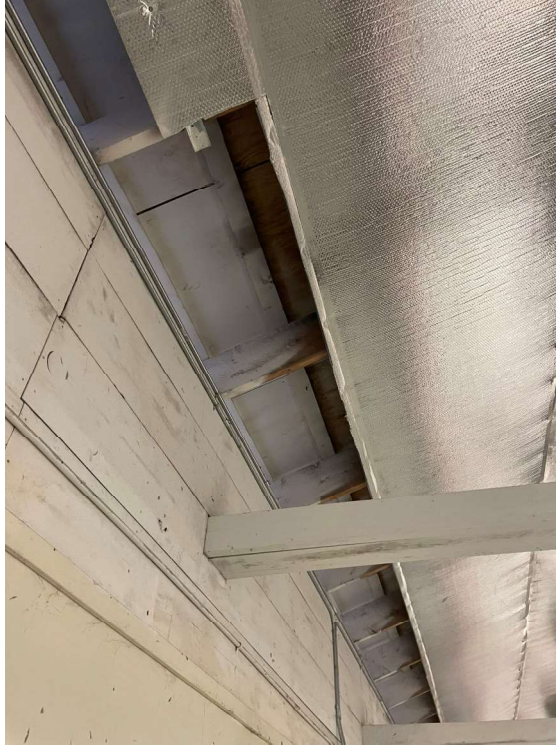
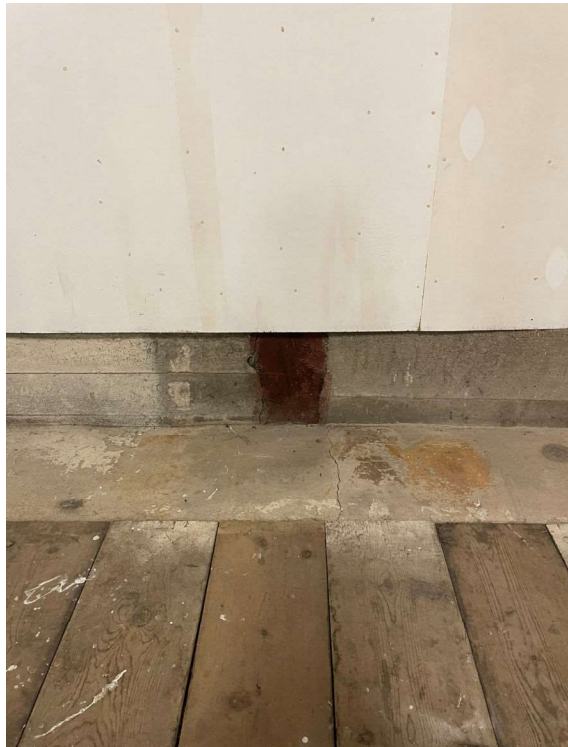
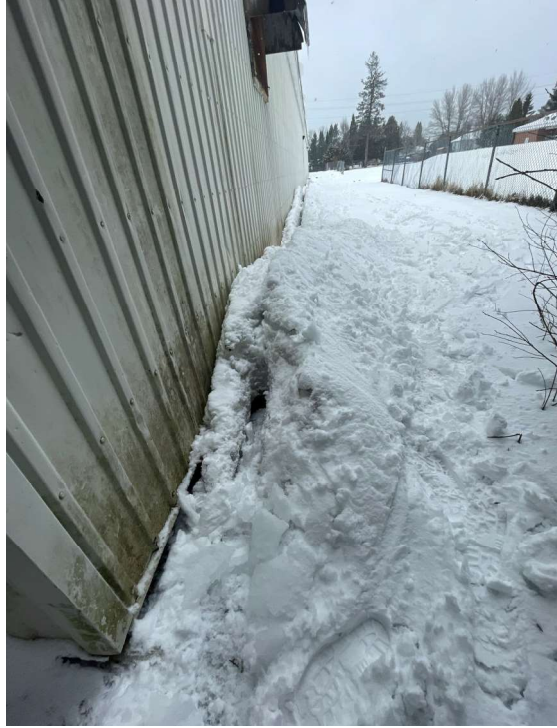
Arena buildings are subject to significant changes in temperature and humidity throughout each season. Given this fact, coupled with the age of the original pole barn construction, and subsequent interior timber column steel bracket reinforcement, we assume the encased timber posts are deteriorating below grade and are relying on the steel reinforcement brackets to transfer vertical and horizontal loads to the slab-on-grade of unknown depth. Moreover, the outer wood columns are likely not able to properly dry-out due to the limitations of the existing building envelope. This is exasperated, by the high exterior grade level and snow which slides off the sloped roof and piles up adjacent to the exterior of building, amplifying the wet conditions (Photograph 3.1.6 to 3.1.8).

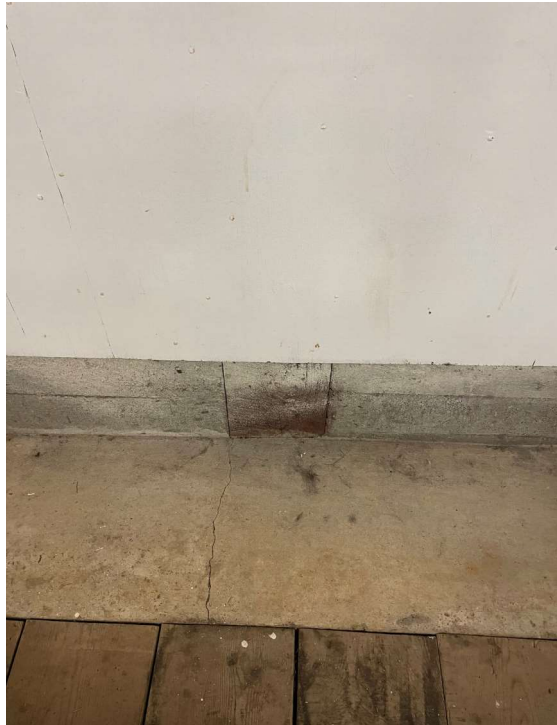
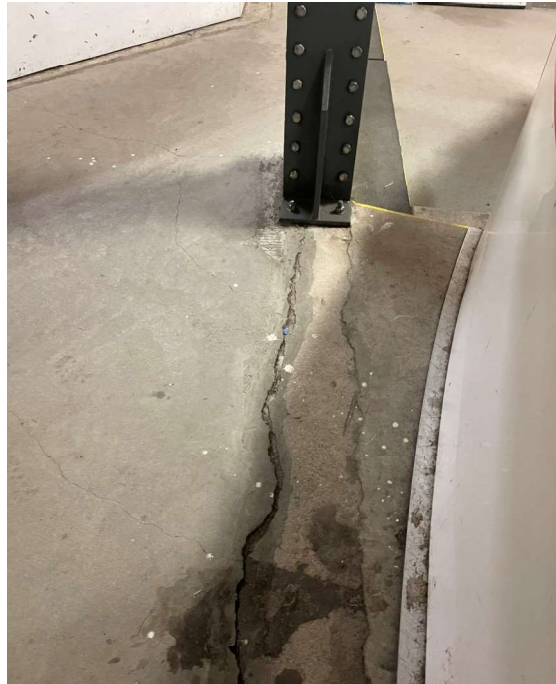
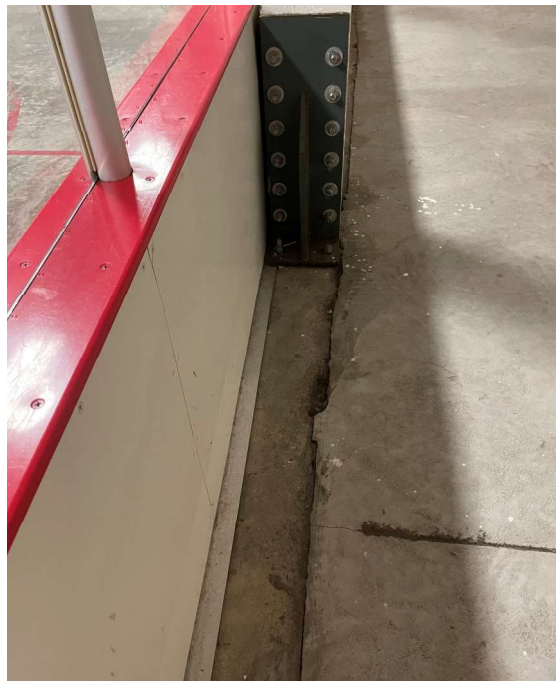
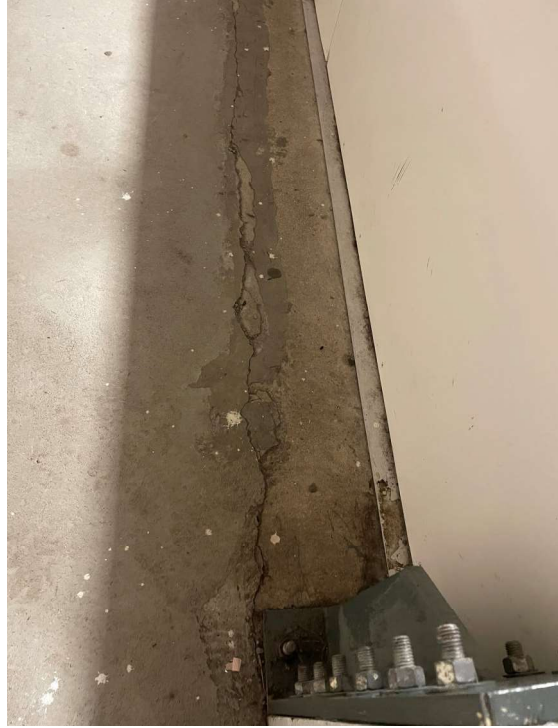
1. We observed cracks in the slab-on-grade around the timber posts (Photograph 3.1.9 to 3.1.12). We are concerned this is likely the result of differential settlement of the timber posts or the slab is of insufficient strength or thickness to support the post loads. We recommend a detailed structural investigation including intrusive testing be completed at representative interior and exterior timber support columns. The investigation should include a structural analysis under the design loads to determine horizontal and vertical reactions at the bases of the column supports. Following shoring and excavation to obtain the sub-surface conditions and the historical as-built reinforcement details, a suitable retrofit can be designed and implemented throughout the arena for each post location as may be required.

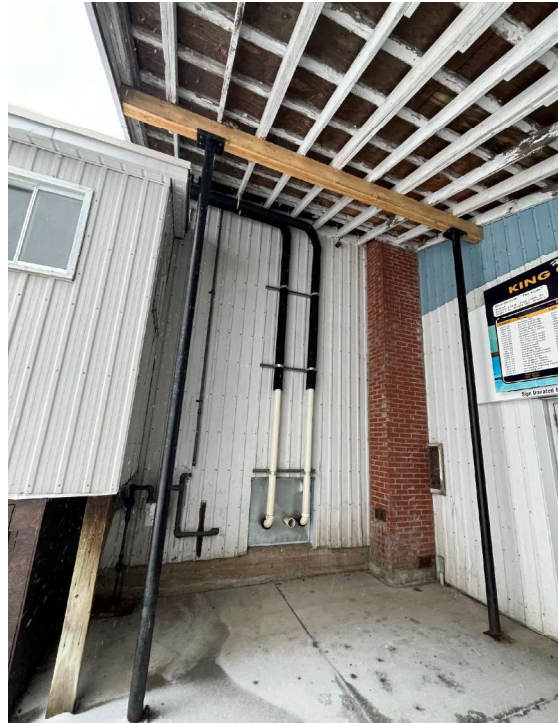
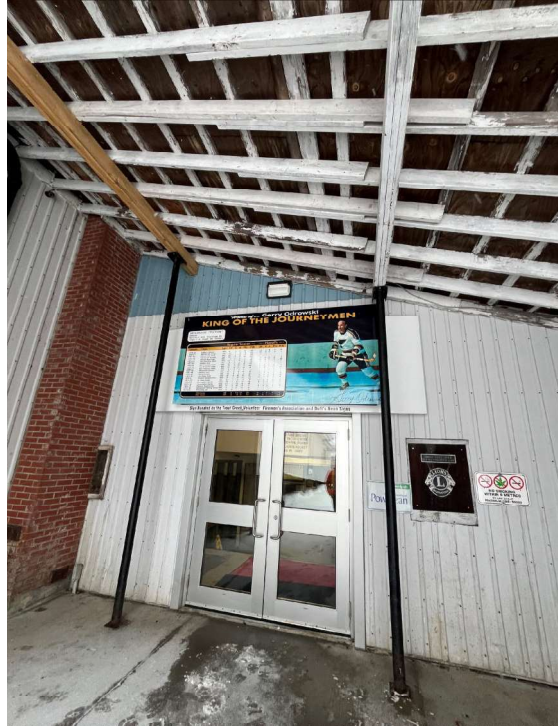
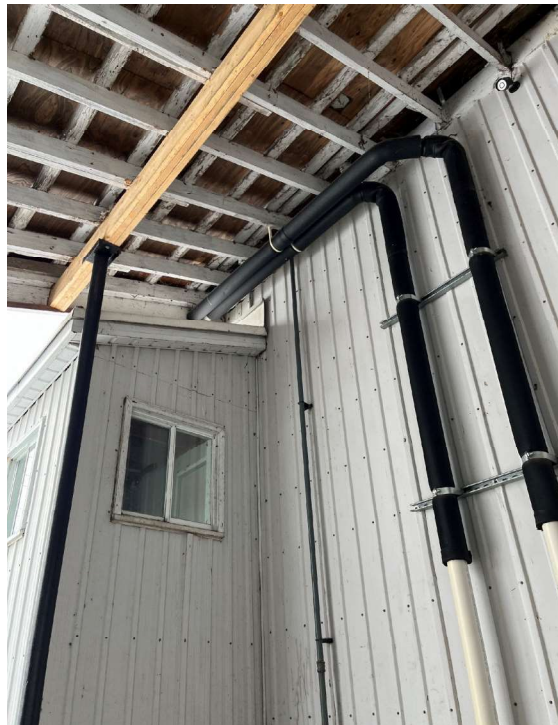
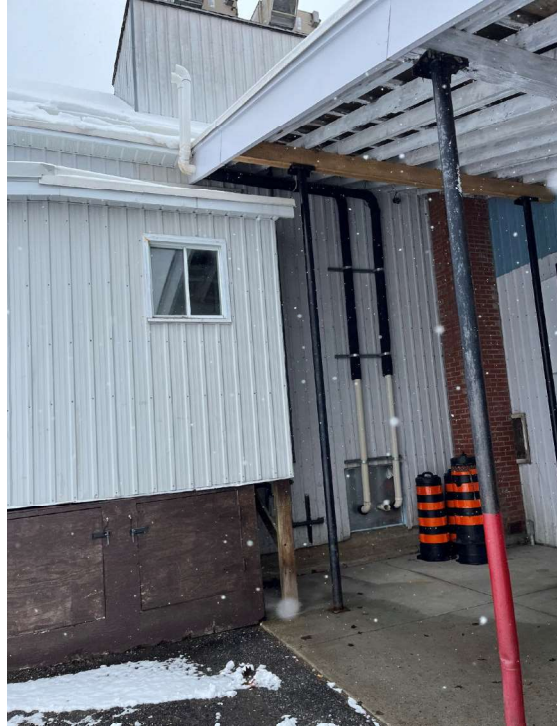
2. We observed several structural modifications and/or alterations for which no engineering records have been provided (Photograph 3.1.13 to 3.1.16). Among these modifications,

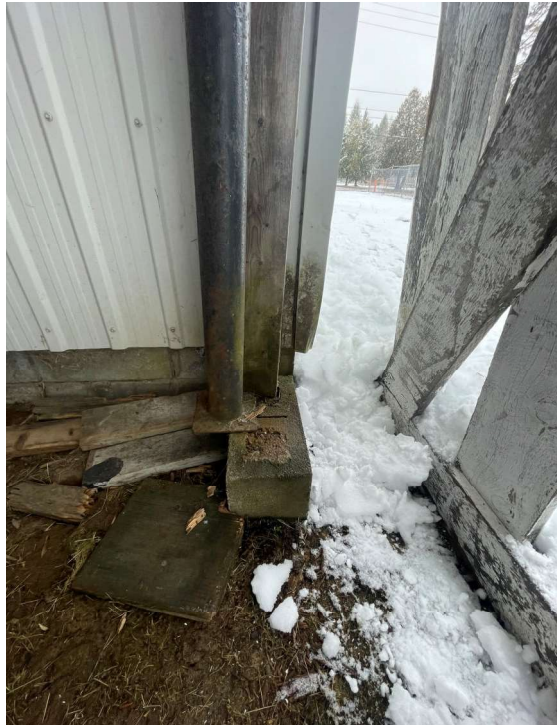
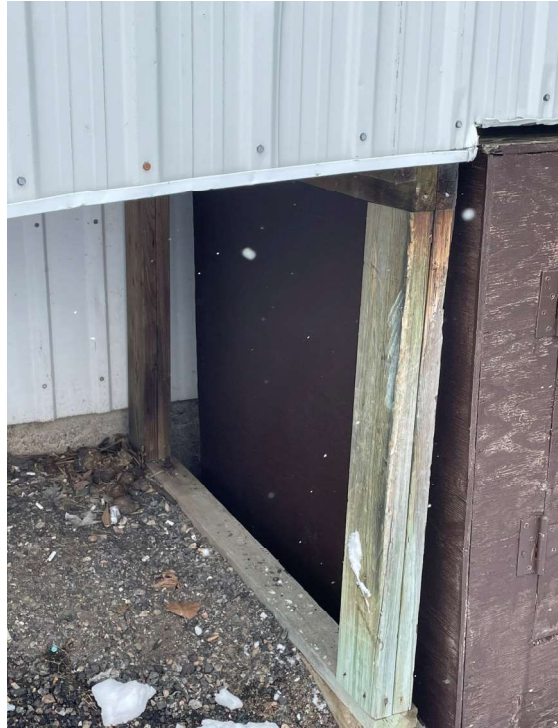
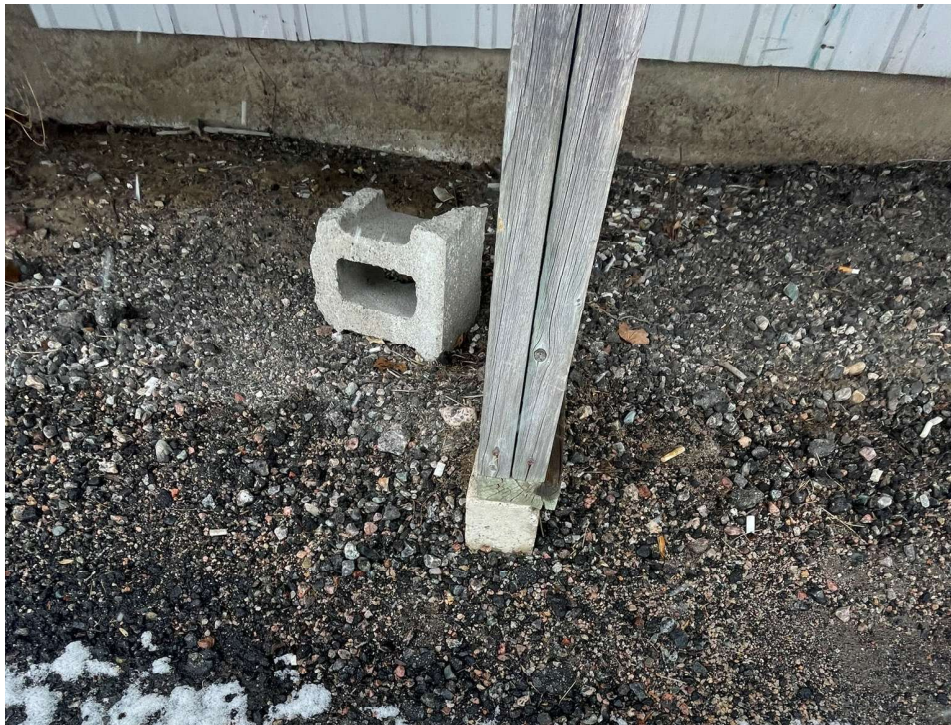
various posts appear to be inadequately supported (Photograph 3.1.17 to 3.1.19). We recommend detailed analysis by a structural engineer of the various modifications to ensure they meet current Ontario Building Code requirements.

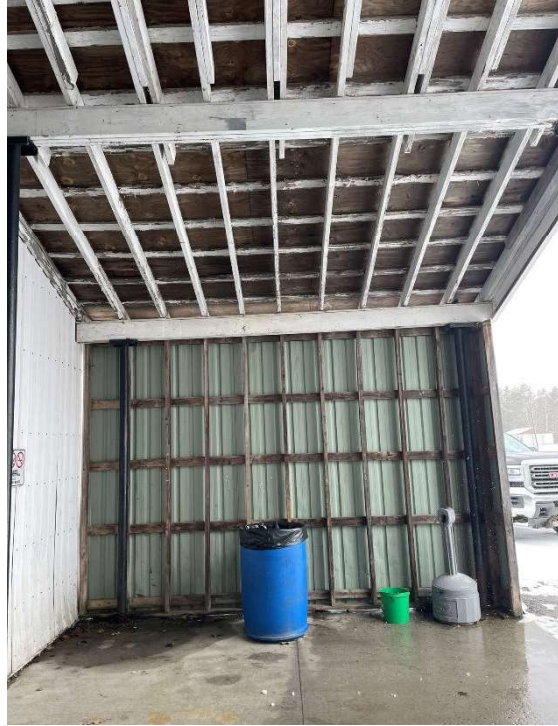
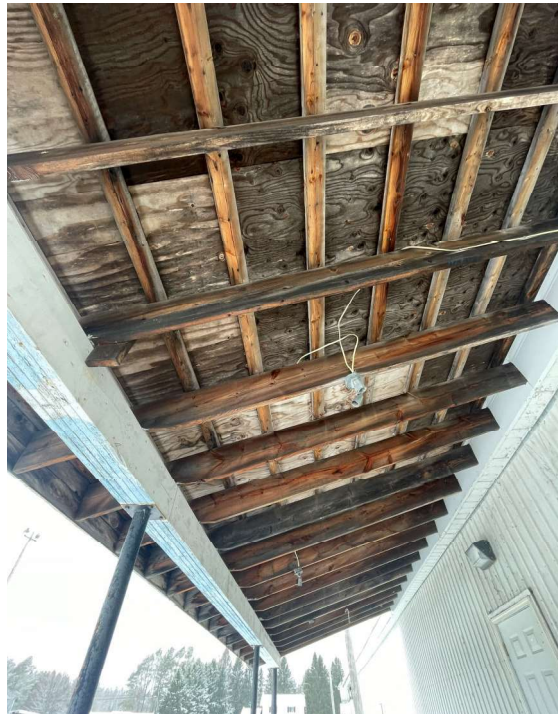
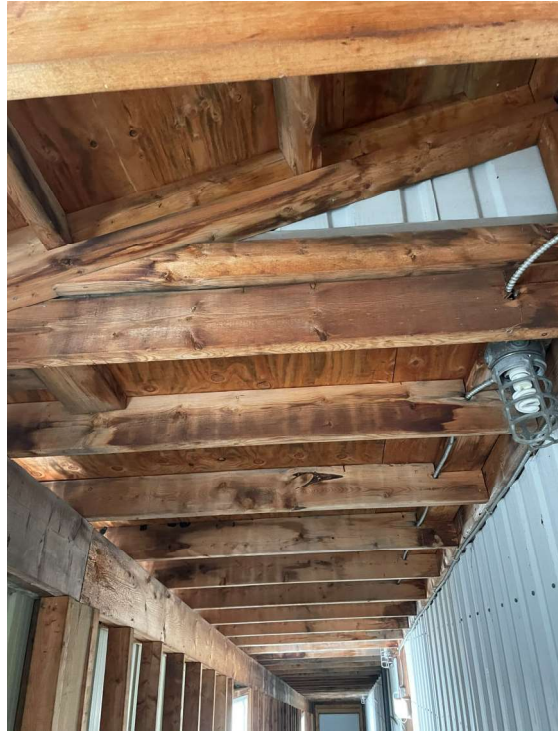
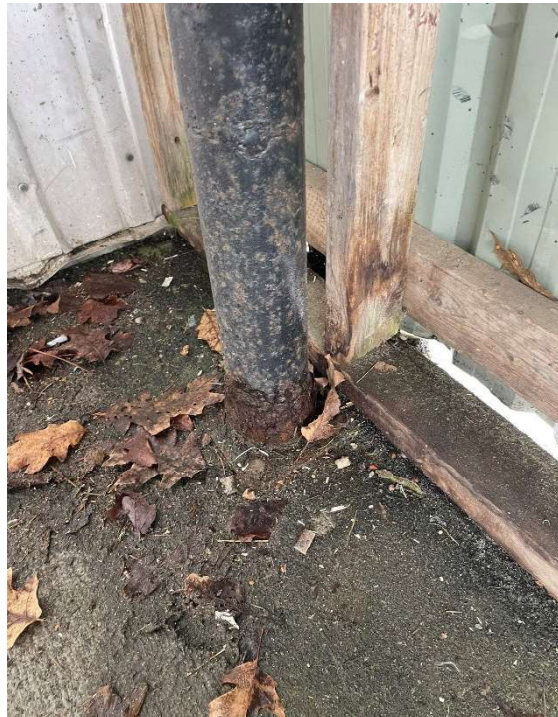
3. In many cases at the exterior structures, posts and exposed wood or timber framed structures are unprotected from the elements or in the case of posts, which are slender, are unprotected from vehicular impacts from snow removal equipment (Photograph 3.1.20 to 3.1.23).

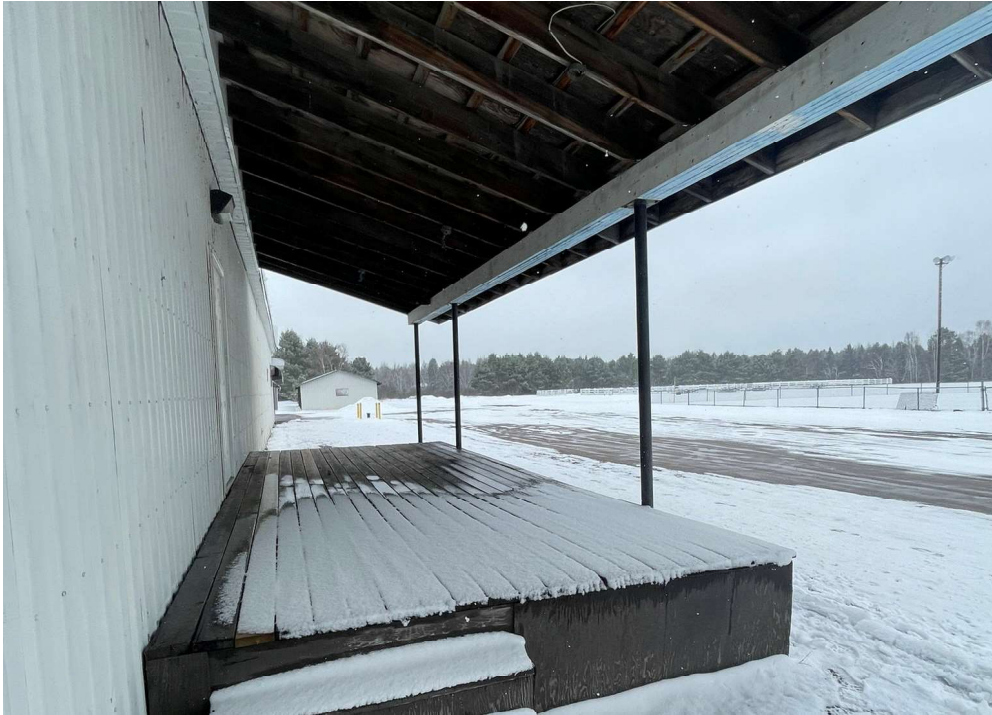
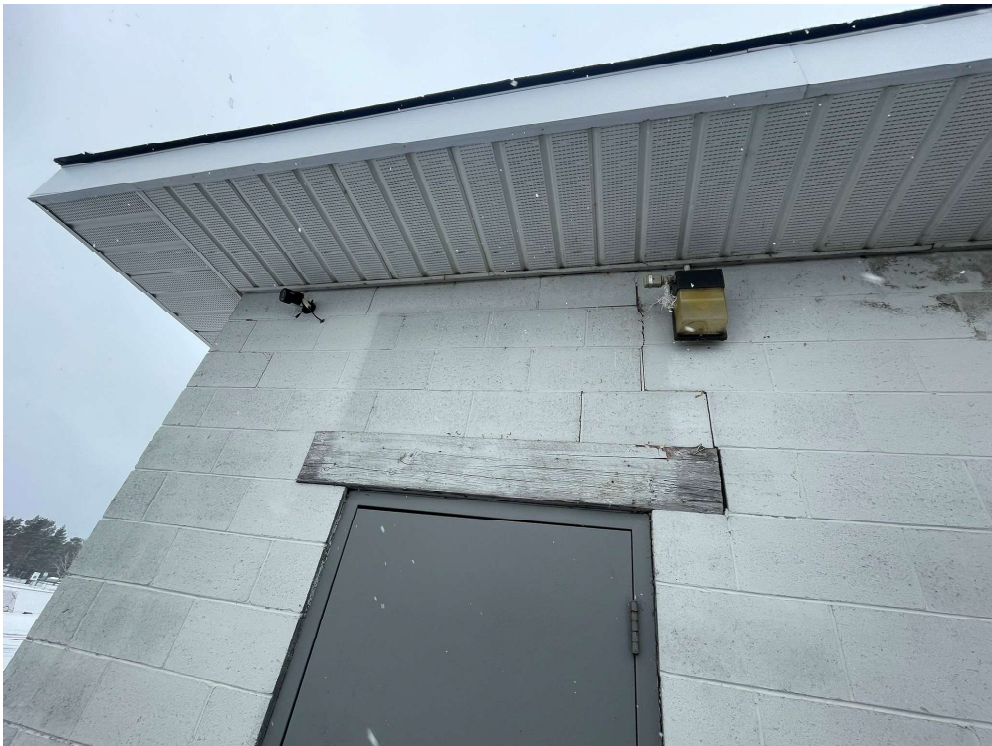
4. We observed cracking around a block lintel over an opening in the back of the building. We recommend a steel lintel be provided and the cracked mortar to be routed and sealed (Photograph 3.1.24 and 3.1.25).

3.1.3	Block wall repairs and Lintel	Within 1 year	\$7,500
3.1.4	Chimney Repairs	Within 1 year	\$8,500
3.1.5	Slab-on-grade repairs	Within 1 year	\$20,000
3.1.6	Block wall repairs	2-3 years	\$5,000

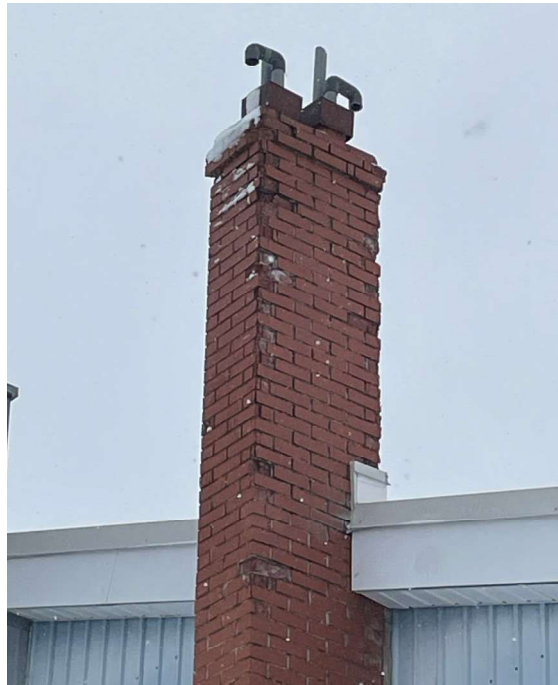
Photograph 3.1.27

5. We observed an existing chimney is need of extensive repairs (Photograph 3.1.27). We recommend the chimney be rebuilt or removed if it is no longer required in service.

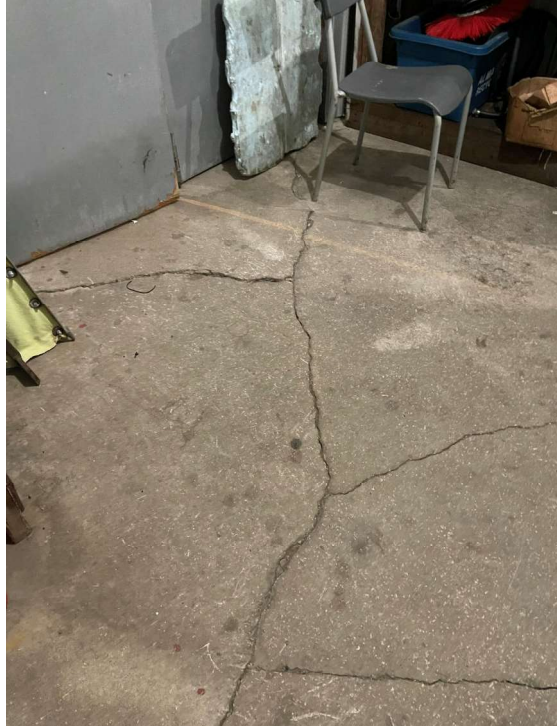
Photograph 3.1.28

6. We observed deteriorated and cracked concrete around the arena slab-on-grade. We recommend minor patch repairs be completed in order to protect the floor and mitigate tripping hazards (Photograph 3.1.28).

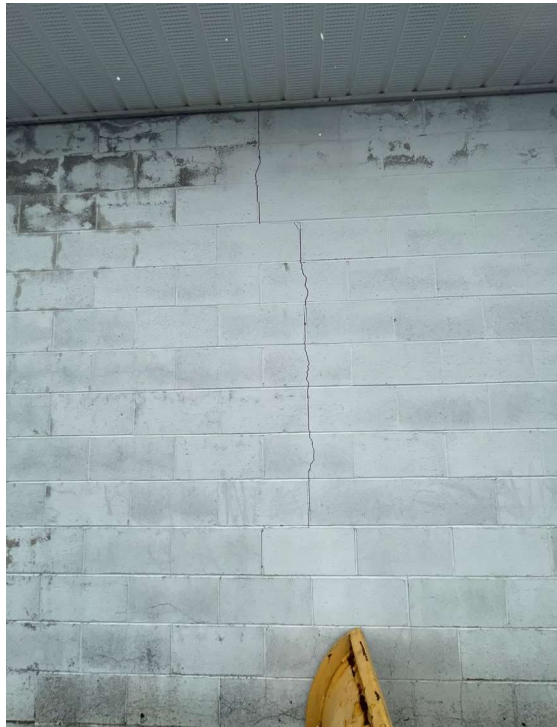
Photograph 3.1.29

7. At various locations on interior and exterior concrete block walls, we observed mortar cracking in need of repair (Photograph 3.1.29). We recommend routing and tuckpointing prior to completing envelope upgrades.

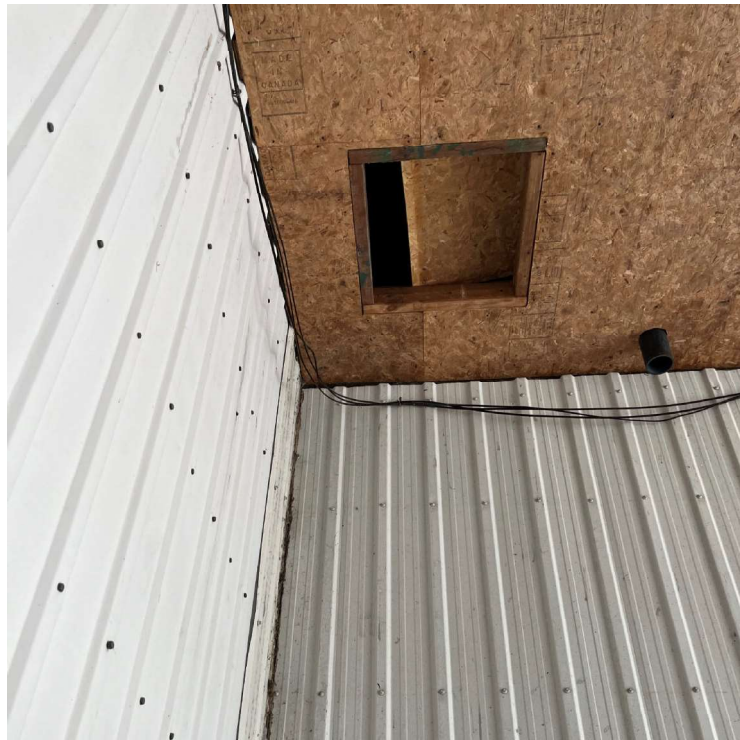
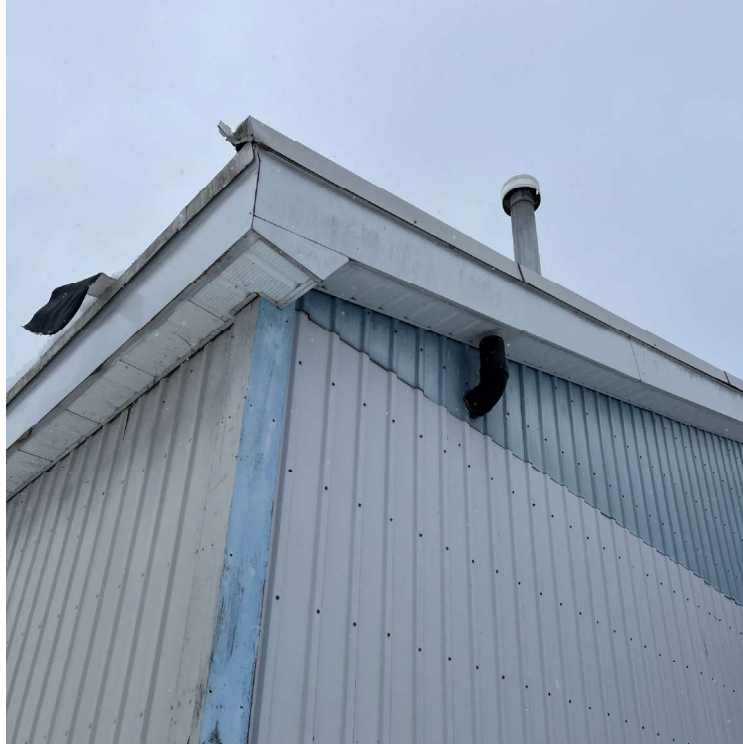
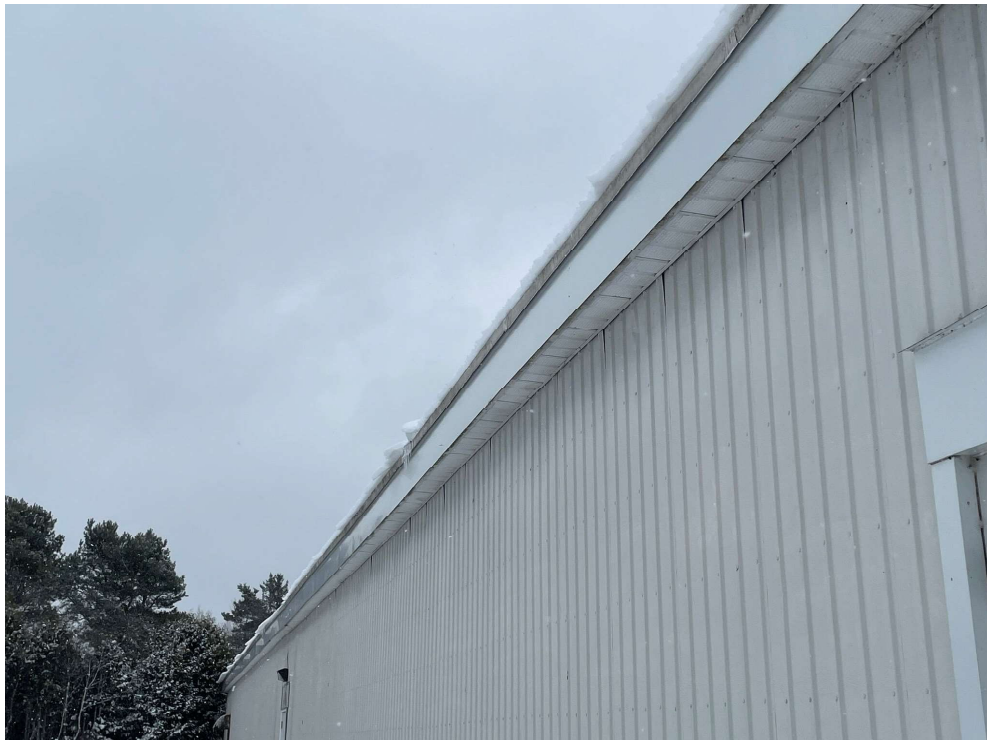
9. We observed torn and repaired roof membrane. We recommend a new roof be designed and installed for the entire facility at the earliest opportunity. Additionally, we observed an unfinished soffit area and the absence of an eavestrough and rainwater leader system

(Photograph 3.1.39 to 3.1.41). This is compounding the problems with the snow pileup around the perimeter of the building. For enhanced surface drainage, a swale should be provided around the perimeter of the building to protect the building and foundations from water damage.

3.1.7	Roof replacement	2-3 years	\$250,000
3.1.8	Building envelope replacement	2-3 years	\$750,000
3.2.1	Replace existing cover wraps for wrap around luminaires	Within 1 year	\$1,000

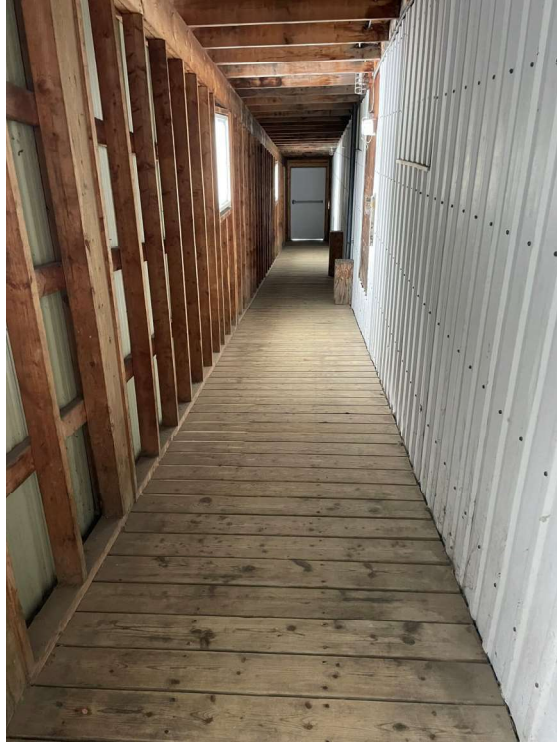
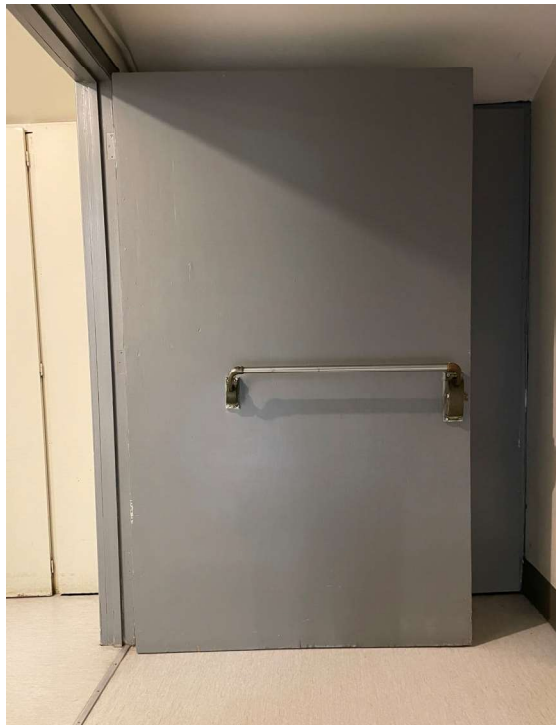
9. A ramp has been provided but is not current Ontario Building Code (OBC) or AODA compliant. Additionally, an egress door with panic bar needs to be replaced so it is in compliance with the OBC. We recommend an AODA review and a code review be performed throughout the building (Photographs 3.1.42 and 3.1.43).

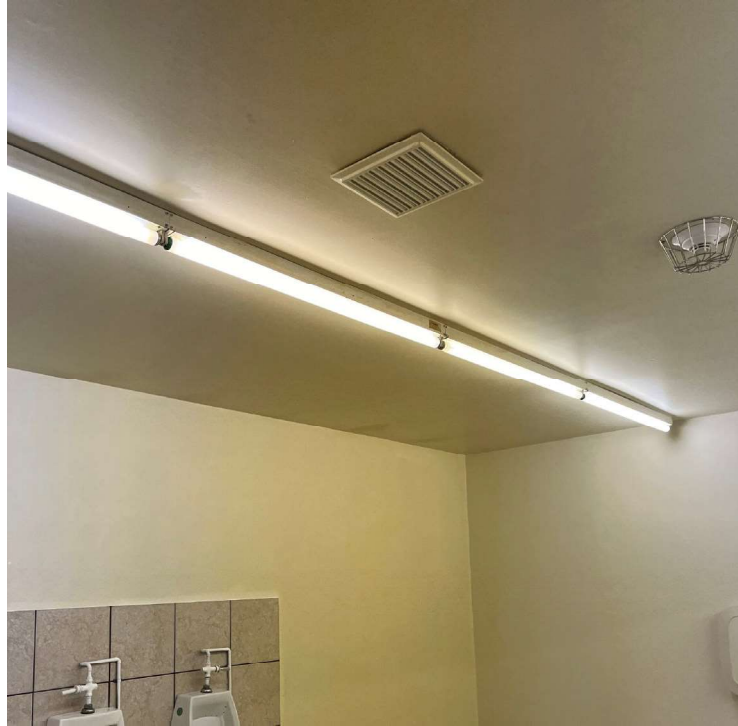
Photograph 3.2.1

1. Interior lighting fluorescent tube luminaires have multiple units without housing covers which may be a concern if the fluorescent tube is damaged (Photograph 3.2.1). Replace existing cover wraps for wrap around luminaires.
2. There is a missing lightbulb (Photograph 3.2.2). Install a replacement bulb.
3. There is wiring in the electrical room appears to be damaged (Photograph 3.2.3). Replacement of this wiring is recommended.
4. Fuse panels should be upgraded to breaker panels (Photograph 3.2.4).
5. A disconnect is required for refrigeration units for the walk-in refrigerator (Photograph 3.2.5).
6. A junction box was found without cover plate. Install one as per code requirements (Photograph 3.2.6).

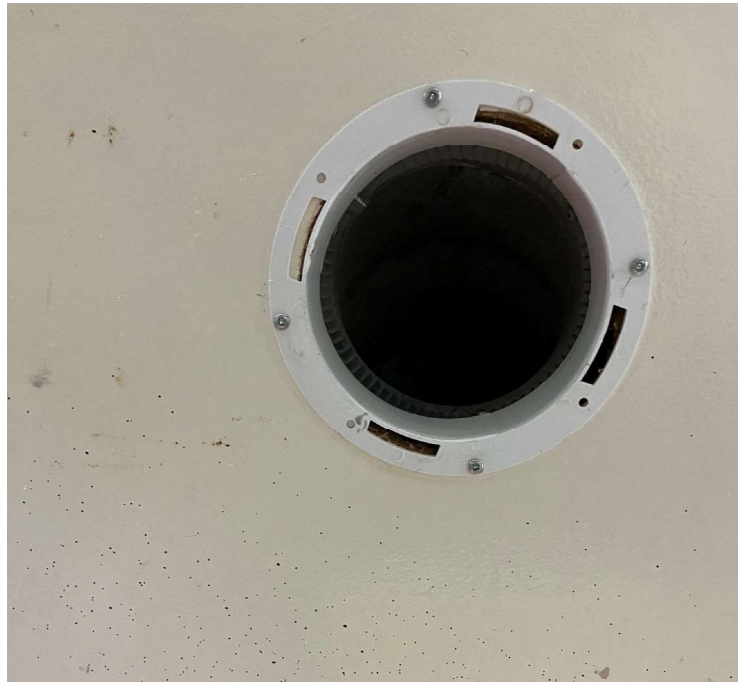
Photograph 3.3.1

5. The age of the exhaust fan servicing change room number 1 was not available. It is missing an exhaust grille and is very noisy. A replacement is recommended immediately (Photograph 3.3.1).

3.3.3	Replace roof top cooling units	5-10 years	\$24,000
3.3.4	Replace ice rink dehumidifier	5-10 years	\$70,000
3.3.5	Replace change room 1 exhaust fan	Immediately	\$2,000

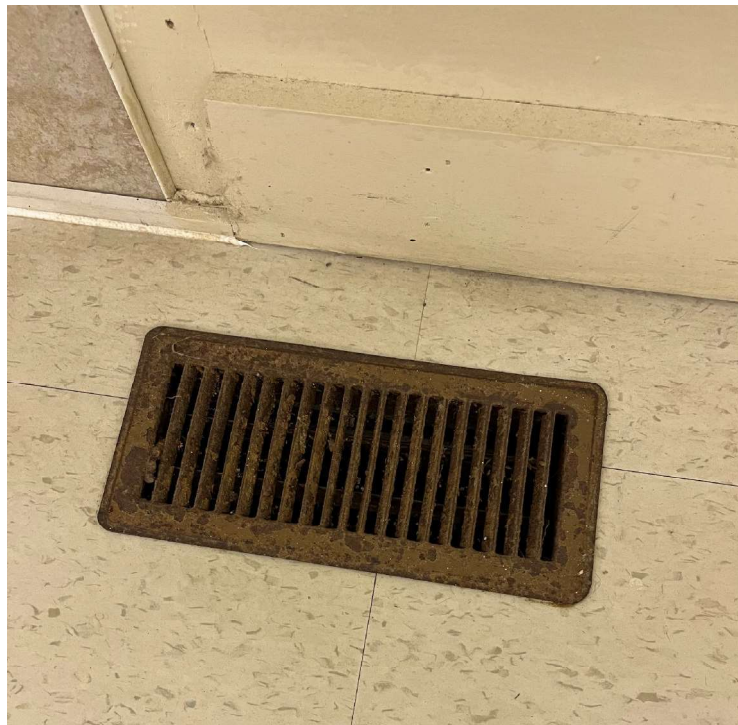
Photograph 3.3.2

6. Some of the air grilles associated with the furnaces are in poor condition. Immediate replacements are recommended (Photograph 3.3.2). There is a return or exhaust, framed with hockey sticks, that doesn't appear to be in good condition and should be replaced.

3.3.6	Replace air grilles in poor condition	Within 1 year	\$1,000
3.3.7	Replace damaged ductwork	Immediately	\$2,000

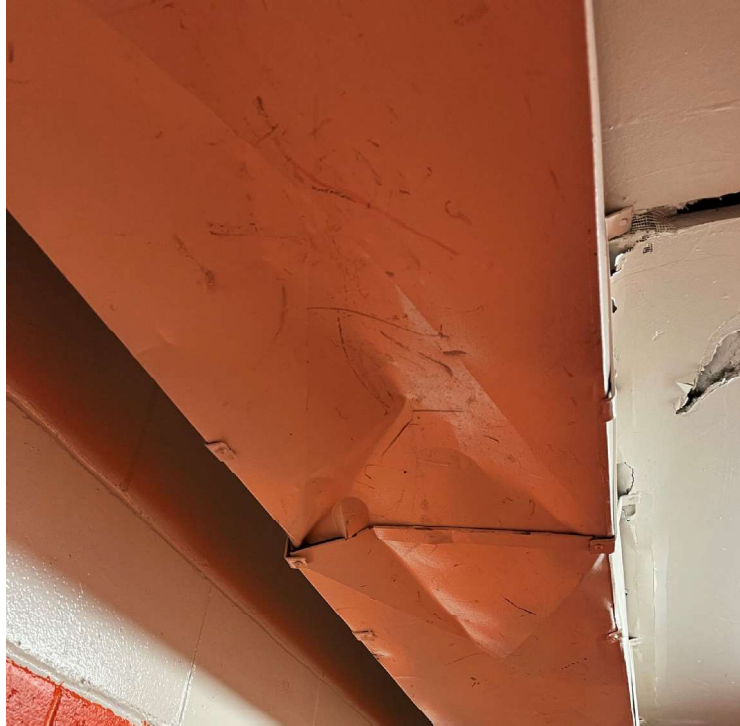
Photograph 3.3.3

7. There is damaged ductwork in the changeroom area. Immediate replacement is recommended (Photograph 3.3.3).
8. The age of the remaining exhaust fans servicing the change rooms was not available. They appear to be in good condition. As per ASHRAE guidelines, the life expectancy of this equipment is 25 years. We recommend the fans be replaced at the end of their useful life.

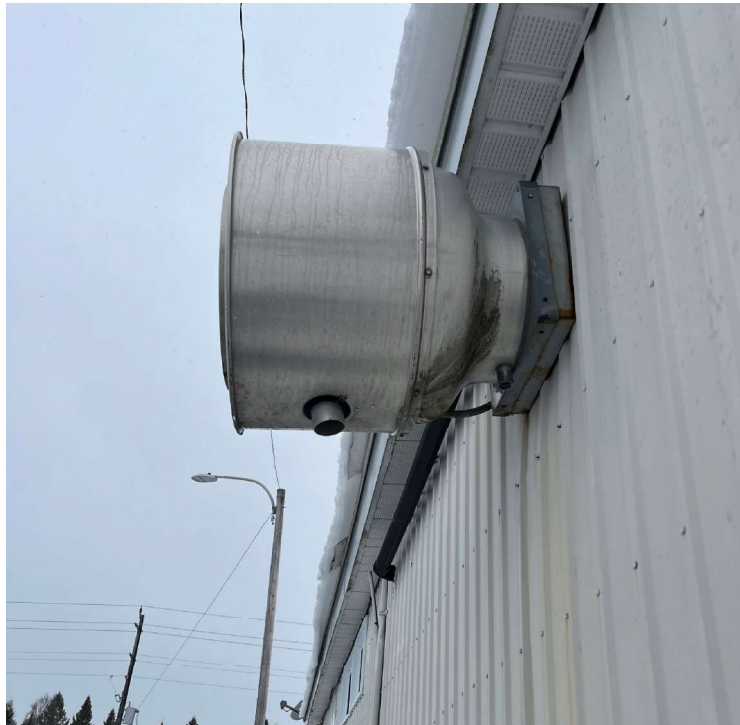
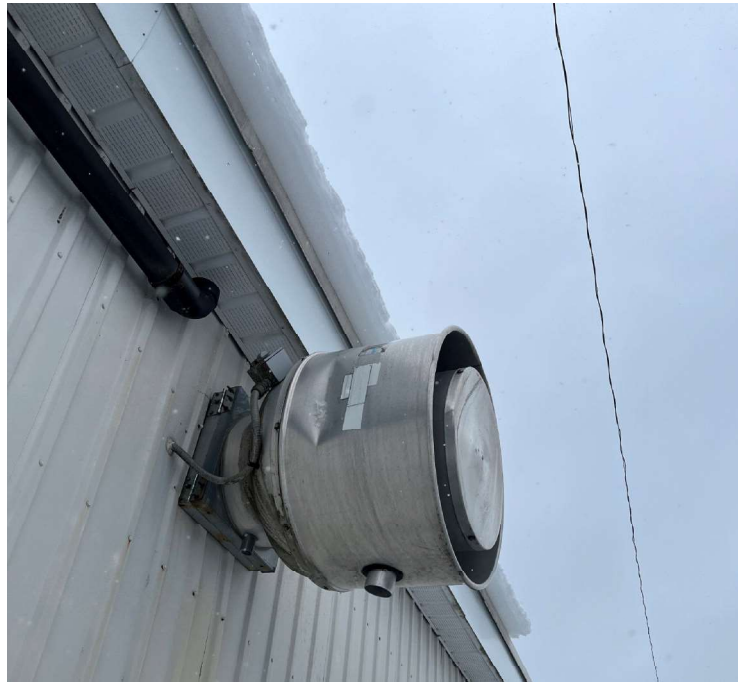
10. The installation date of the kitchen exhaust fan was not available. There is visible damage to the fan, and it is mounted improperly. An immediate replacement is recommended (Photograph 3.3.4 and 3.3.5)

3.3.10	Replace kitchen exhaust fan	Immediately	\$21,000
3.3.11	Replace kitchen exhaust fire suppression system	5-10 years	\$7,000
3.3.12	Replace natural gas hot water tanks in electrical room	5-10 years	\$12,000

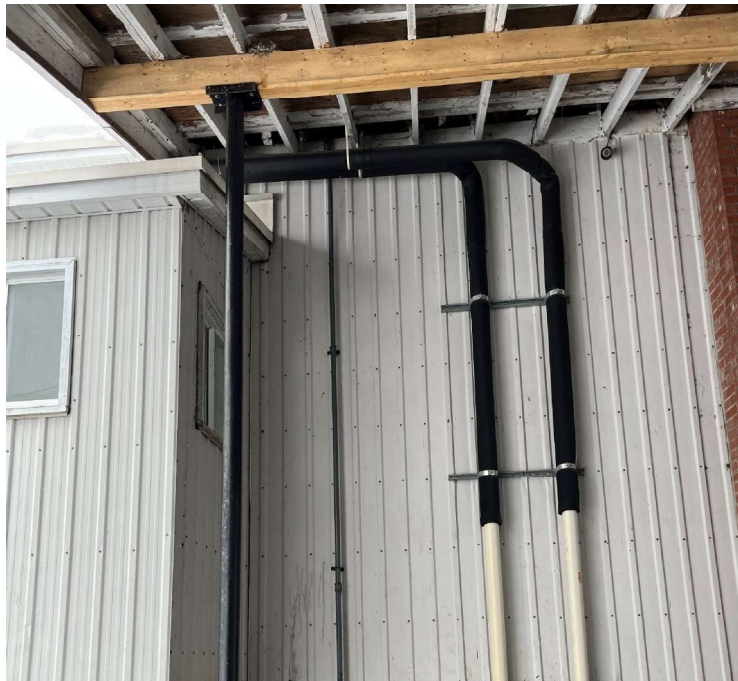
Photograph 3.3.8

30. There is exhaust venting running a considerable distance exterior to the building with partial insulation. The manufacturer installation guide should be referred to for the equipment to ensure the length of pipe external to the building is acceptable. There should be additional insulation added to the sections currently uninsulated (Photograph 3.3.8).
