Appendix A - 2025 Tatham Engineering

File 224503-05

January 20, 2025

Re: Trout Creek Community Centre, 181 Main St. W, Trout Creek
Detailed Structural Investigation

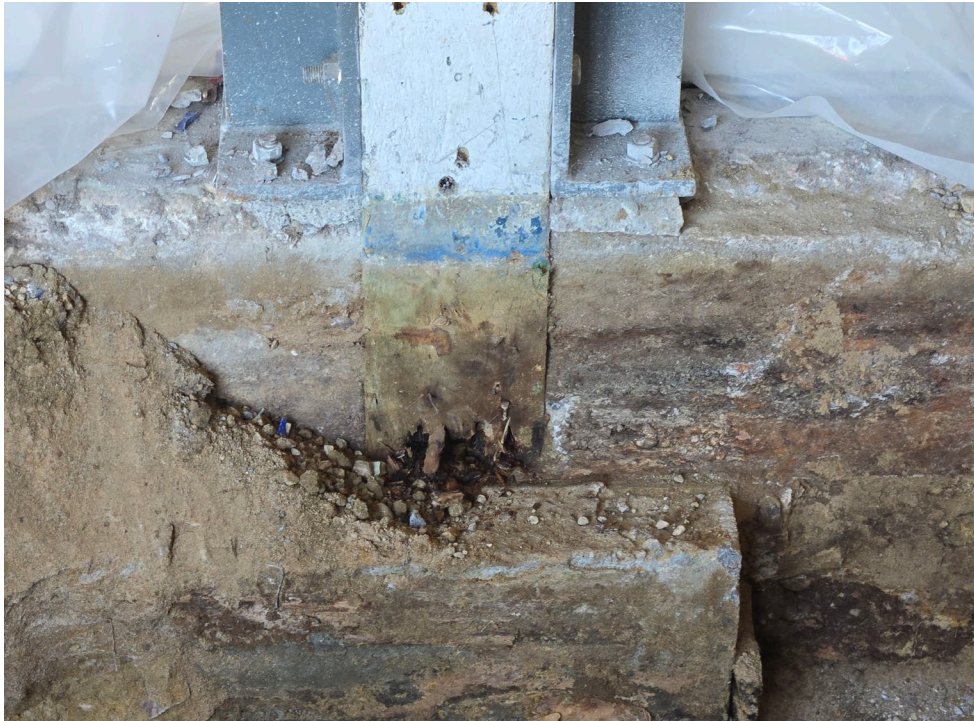
- The wood columns are in direct contact with soil beneath the concrete slab-on-grade floor and have suffered significant localized decay as a result. Settlement of these columns due to decay is evident (refer to Photograph 1).

Photograph 1: Deterioration below slab - interior column

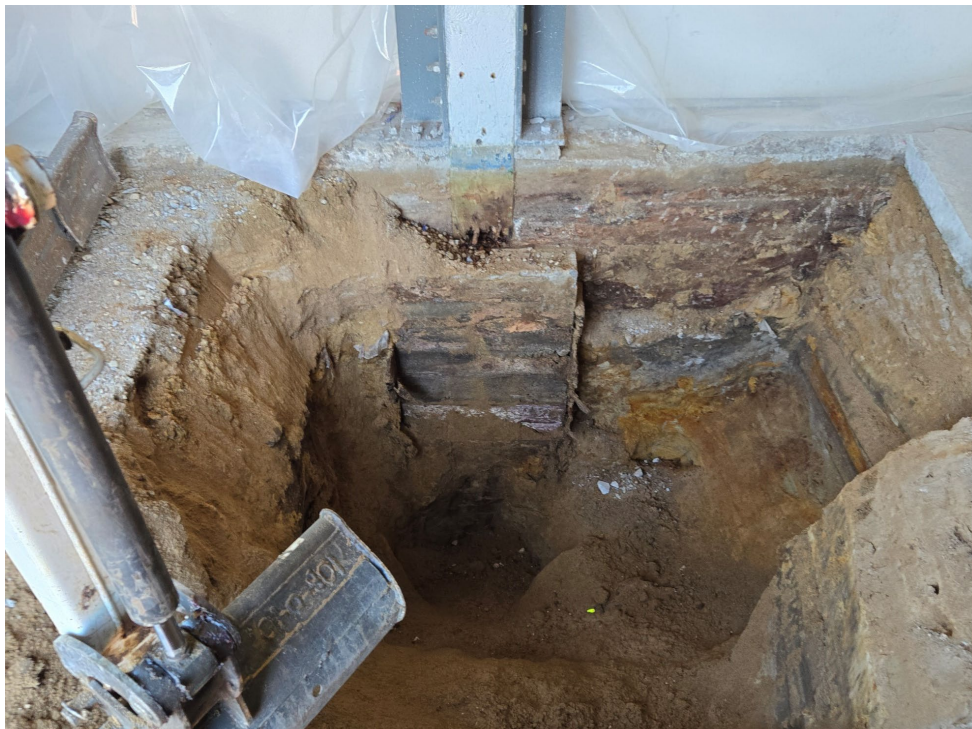
- The wood columns are encased in concrete piers which extend to a 3'-0" x 3'-0" concrete pad footing terminating approximately 6'-0" below the top of slab elevation (refer to Photograph 2).

- A full-depth foundation wall on strip footings extends below the concrete curb surrounding the rink, however it is not connected to the piers at each column (refer to Photograph 2).

Photograph 2: Concrete pier adjacent foundation wall - interior

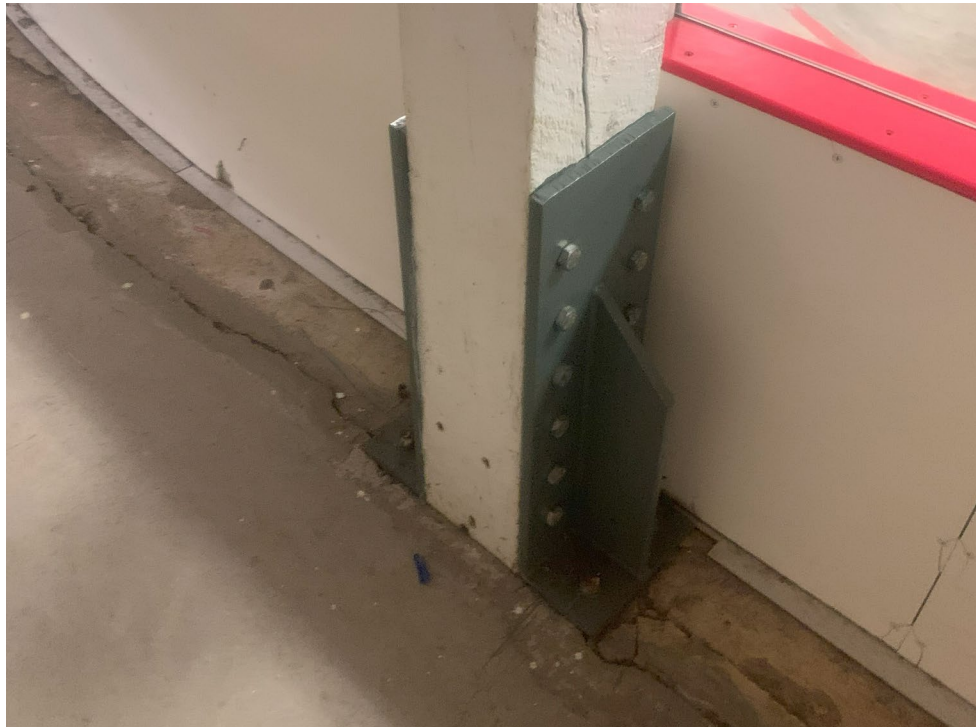
- The retrofit, bolted steel plates at each column provide some support to supplement the capacity lost to decay (refer to Photographs 3 and 4), however they are not sufficient to support the full roof snow loading as prescribed by the Ontario Building Code.

Photograph 3: Retrofit bolted steel plates - interior column

To reduce loading to the severely deteriorated interior columns and undersized retrofit brackets, we recommended installation of a series of temporary posts around the interior perimeter of the arena in accordance with attached drawings S.1 and S.2. This work was completed in December 2024 in accordance with our design and is sufficient, in combination with ongoing monitoring as noted below, to support the interior beams at the perimeter of the rink for the duration of the 2024-25 season.

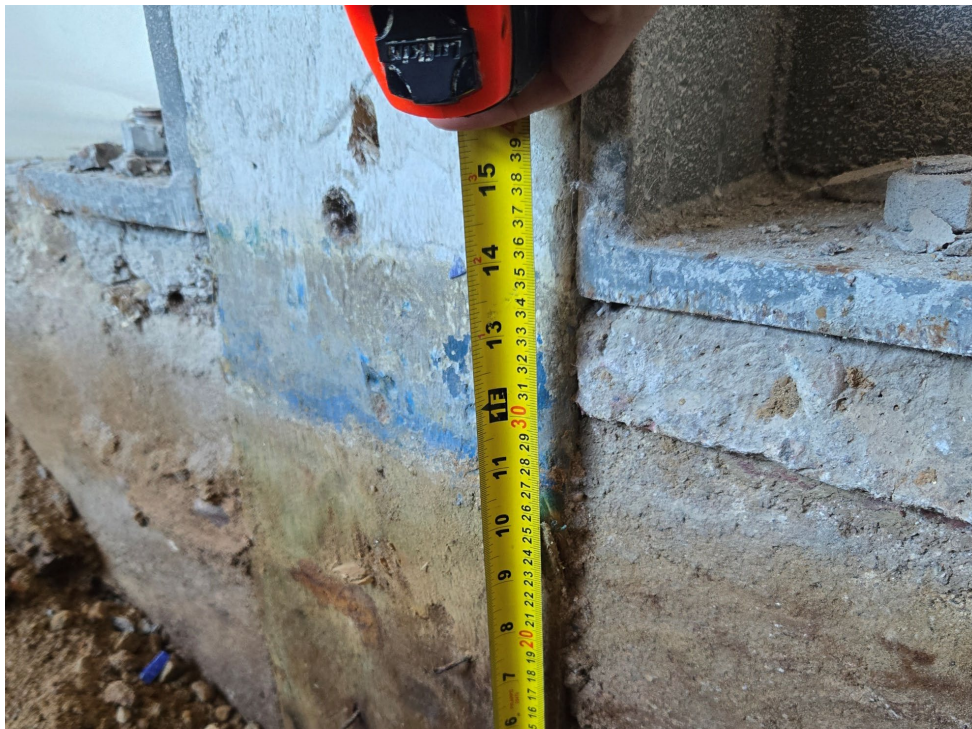
Photograph 4: Retrofit bolted steel plate bearing - interior column

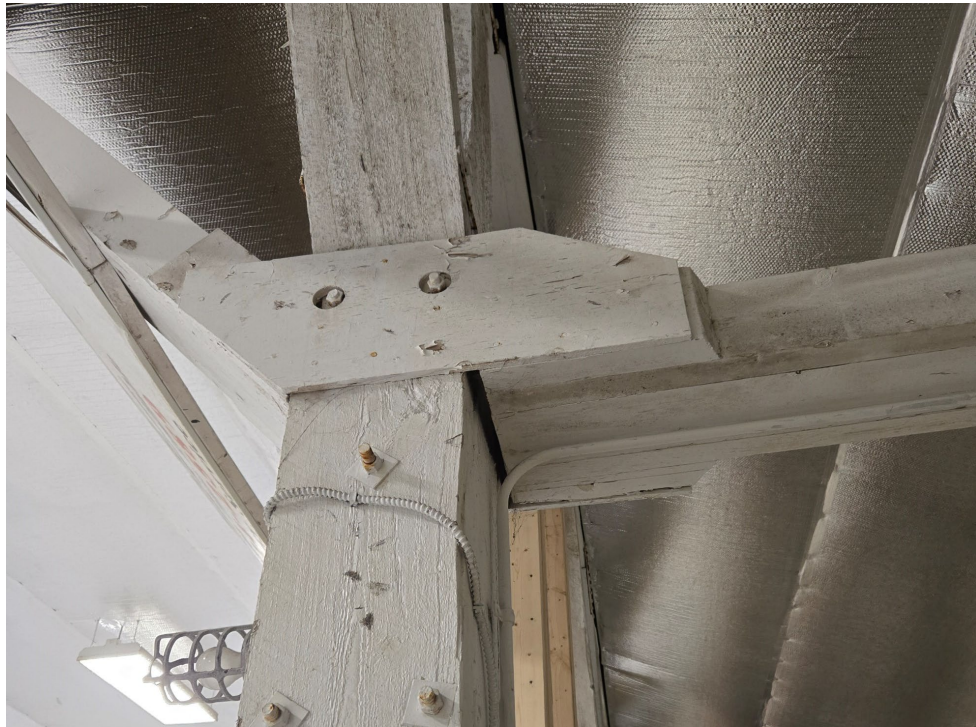
- Settlement of the columns is not uniform, and in localized areas where the settlement is most prominent, the overhead wood structure (beams, angle bracing, horizontal bracing) has been displaced and is at risk of failing (refer to Photograph 5).

Photograph 5: Settlement effects at overhead structure

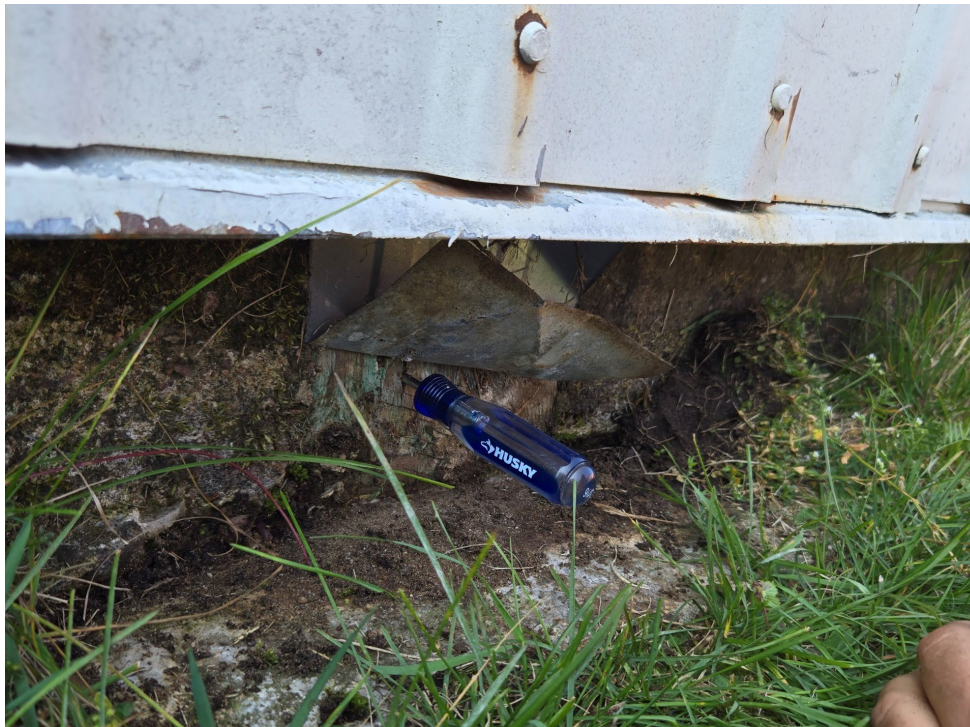
- Wall columns are exposed to exterior grade/moisture at the outside face of the building and have suffered varying levels of decay as a result (refer to Photograph 6).
- In the worst areas of decay, a section of the original columns has been replaced with pressure-treated blocking (no record of this work is available) (refer to Photograph 7).

Photograph 6: Deterioration at original column - exterior

- At the exterior of the arena building, snow shall be kept clear of the building siding at ground level to prevent further moisture exposure and deterioration at the exterior columns.

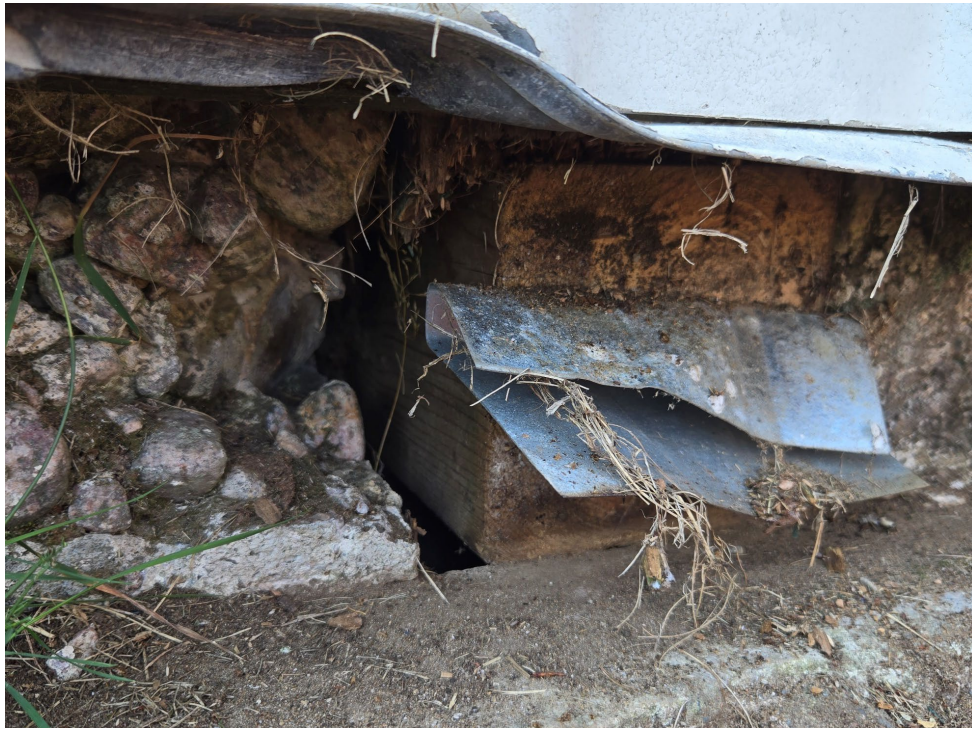
Photograph 7: Blocking at deteriorated column - exterior

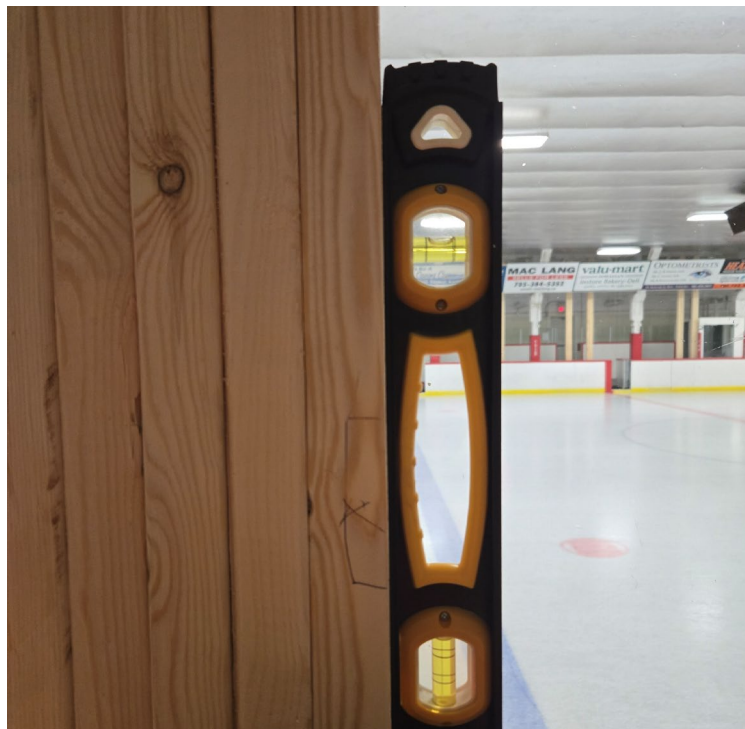
Photograph 8: Marked post and level check at representative monitoring location

- A total of five of the new interior shoring posts around the arena have been marked for plumb/level checks (refer to Photograph 8). These locations are to be checked daily by Town staff using a 2' or 4' level as a first-indicator of any movement. If an out-of-plumb reading is noted at any post, Tatham is to be contacted for review.

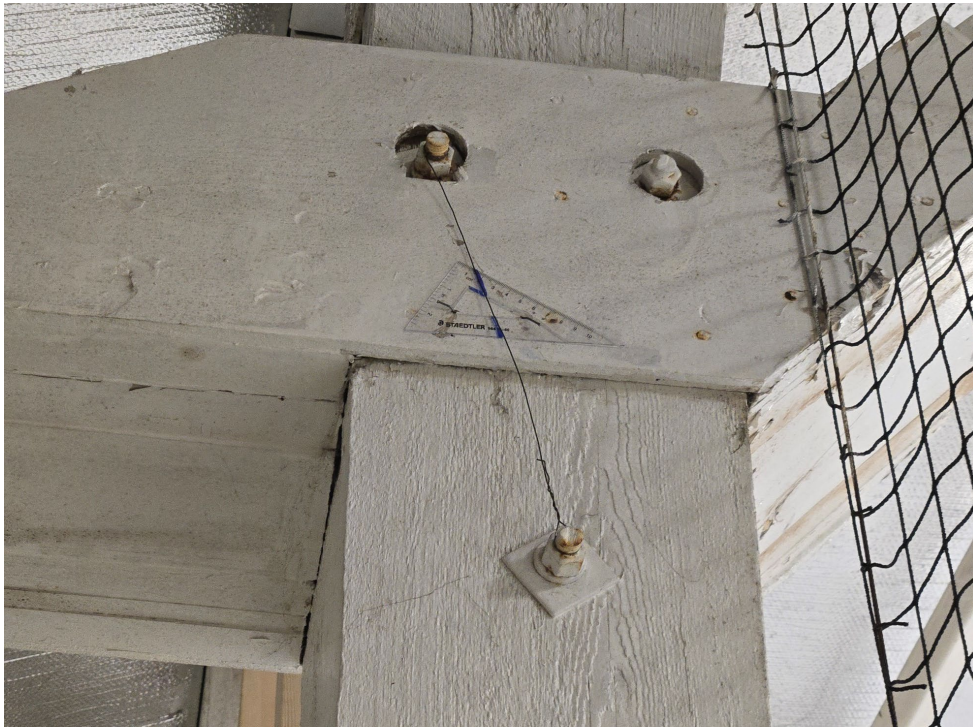
Photograph 9: Representative monitoring between column and adjacent structure

- Monitoring lines have been established at a representative sample (six) of the existing interior columns (refer to Photographs 9 and 10). These setups at the top of the columns are designed to indicate differential movement between the column and the beam structure above. These are also to be checked on a daily walkthrough by Town staff for any movement. If movement away from the baseline is observed, Tatham is to be contacted for review.

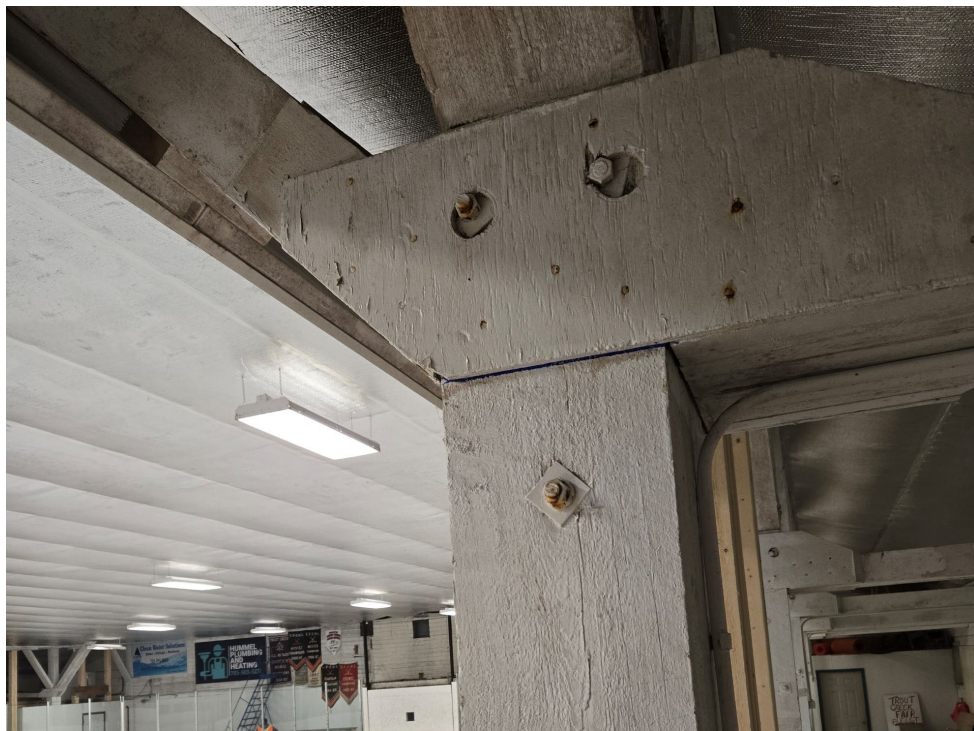
Photograph 10: Basic monitoring line at representative column location
