Municipality of Powassan

Trout Creek Community Centre – Building Condition Assessment

Project No. 20-1243-2

October 2020

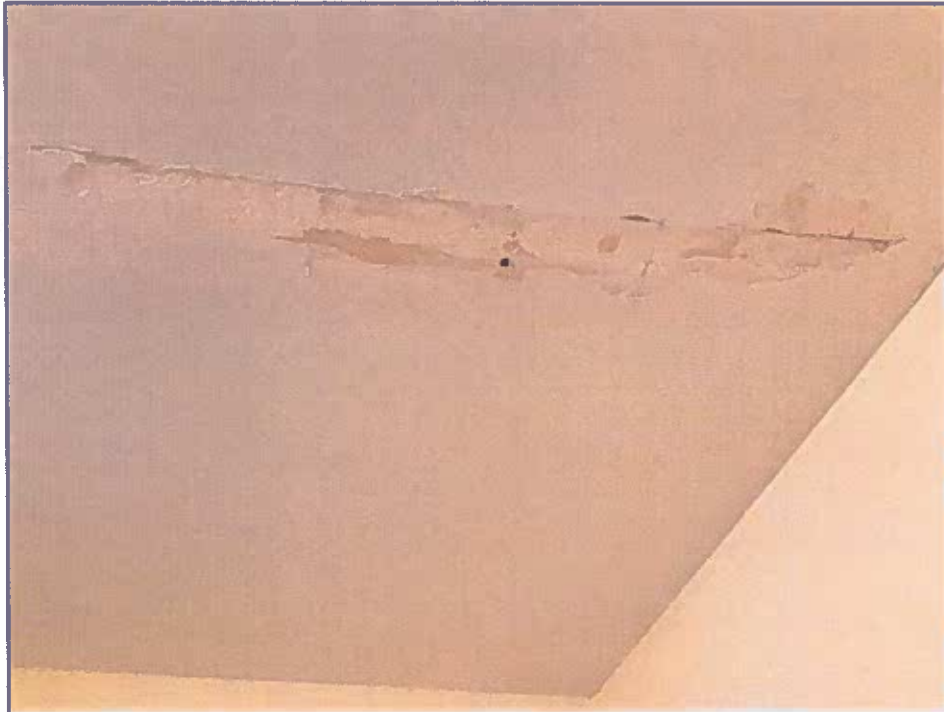
Photograph 5: Moisture damage in ceiling in women's washroom, previous leak reported to be repaired

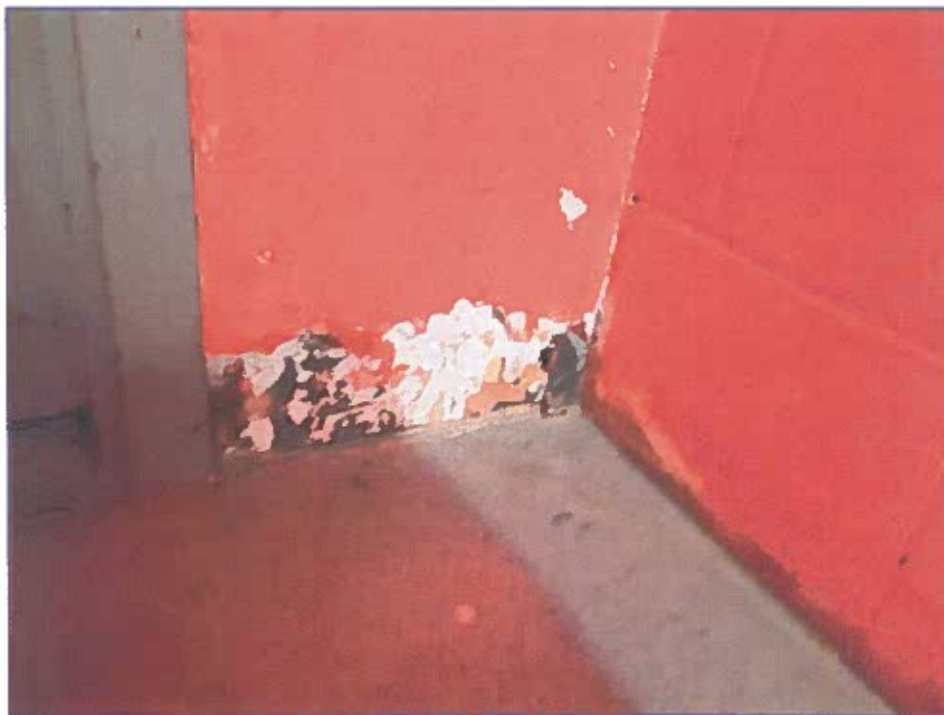
Photograph 6: Damaged drywall in hallway leading to dressing rooms

8. Repair all interior finishes which have been damaged (drywall in hallway, parging/painting in dressing rooms, carpet in managers office) ✓
9. Asphalt repairs at north side of building

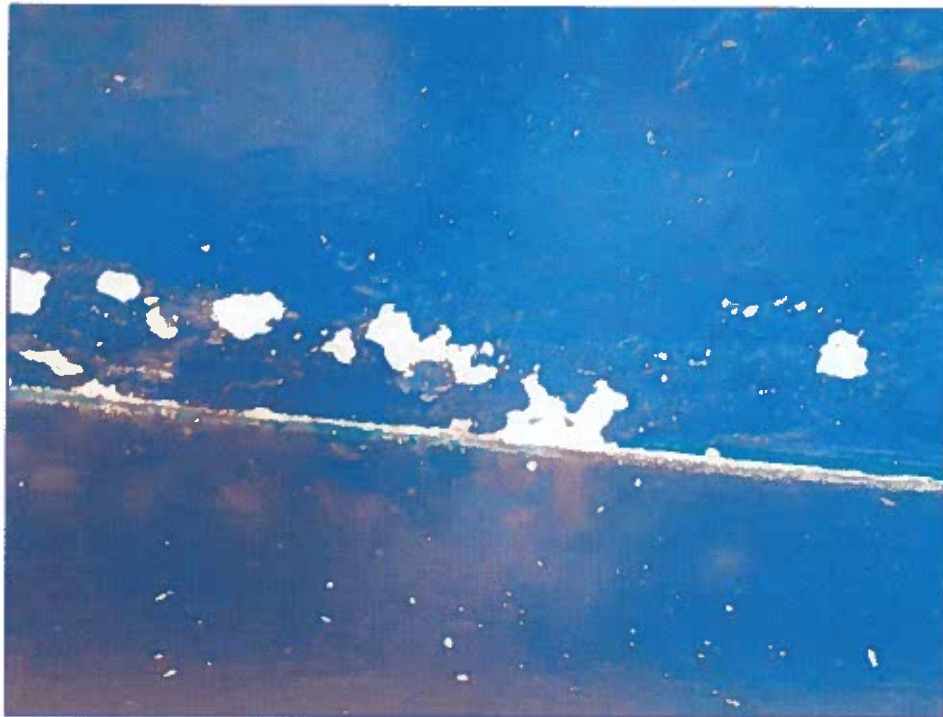
Photograph 8: Damaged parging and flaking of paint in dressing rooms

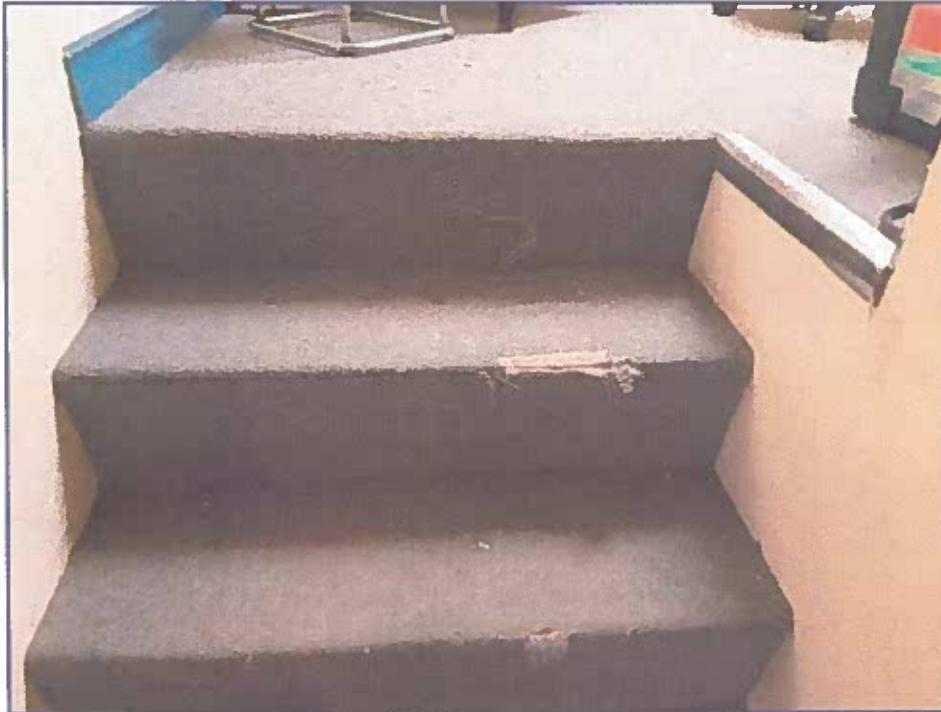
Photograph 9: Damaged carpet in managers office

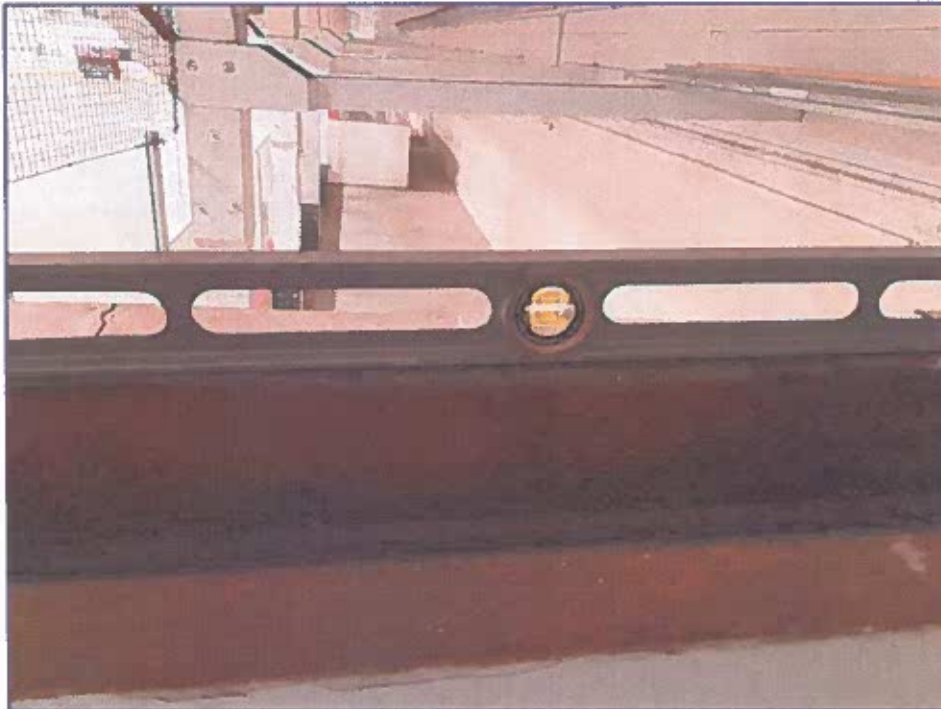
Photograph 10: Side bracing at southwest corner is sagging

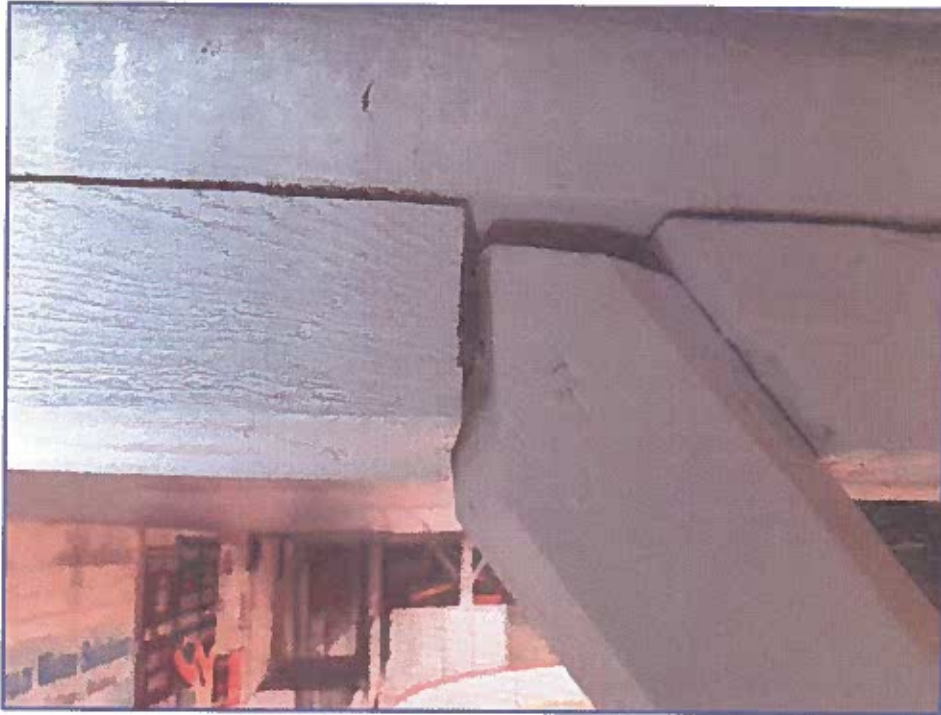
Photograph 11: Knee brace to roof beam connection is separating at southwest corner of structure

3. Replace all areas of damaged siding.
4. Wire brush and paint existing steel base plates at bottom of columns around the rink surface.
5. Add a steel gusset plate to the knee braces which are separating from the roof beam.

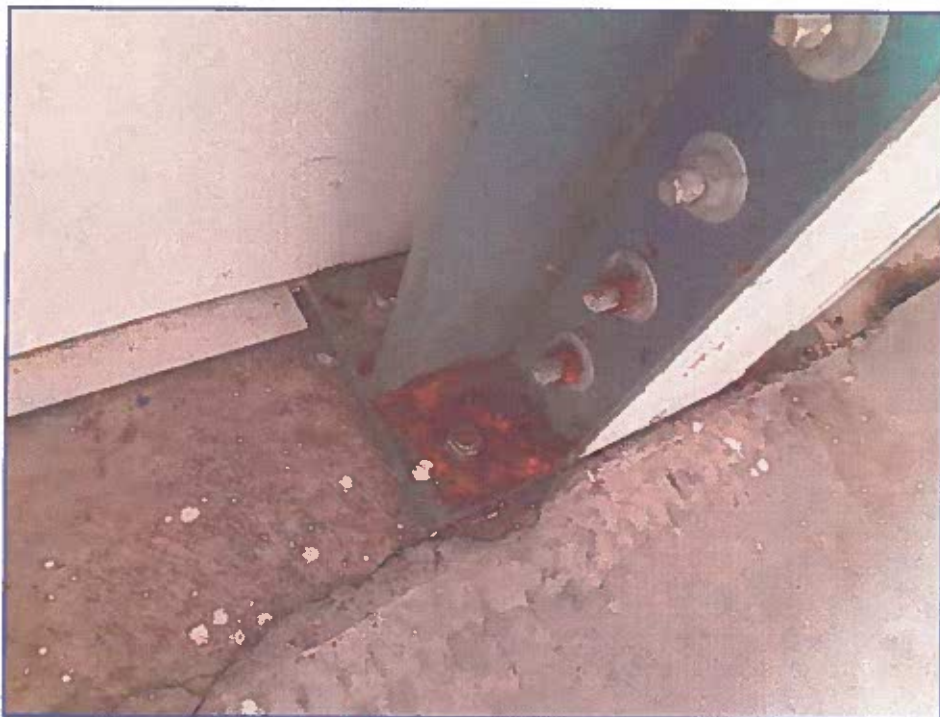
Photograph 12: Noted steel base plates which were reported to be installed in or around 2008 at the bottom of the wood columns starting to corrode, no section loss noted

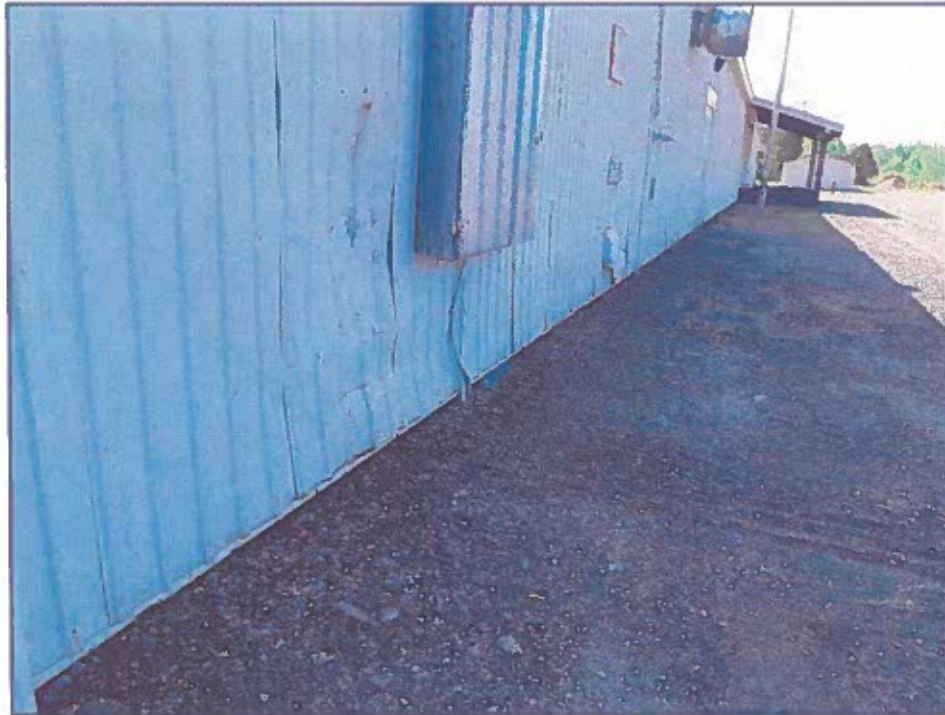
Photograph 13: Damaged steel siding throughout

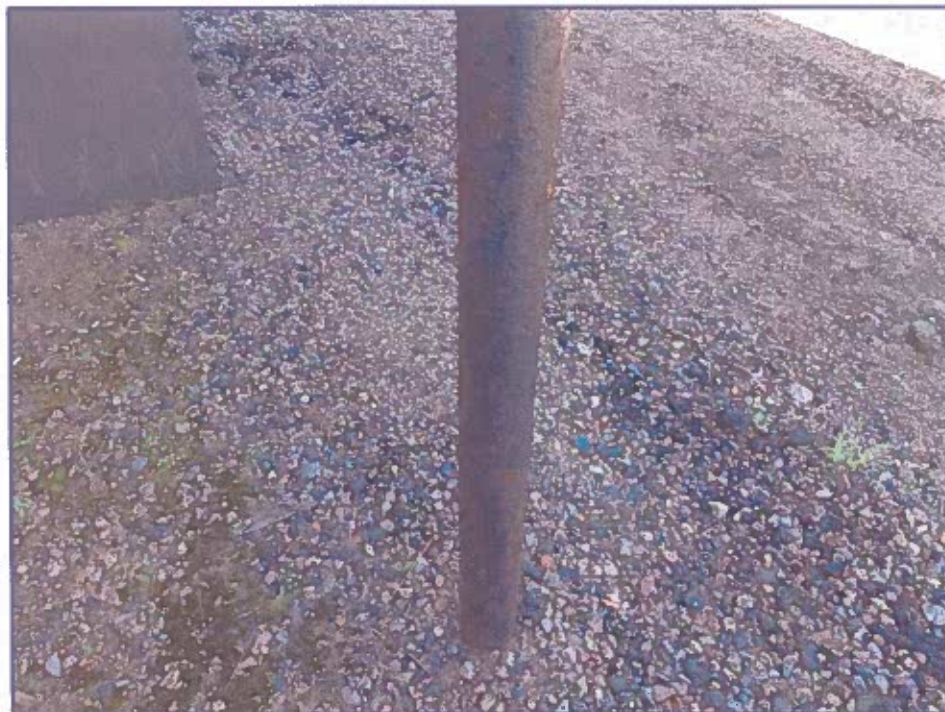
Photograph 14: Minor corrosion of steel posts supporting west roof overhang

6. Install protection system (bollards or large concrete blocks) around steel posts which support west roof overhang.
7. Wire brush and paint all steel posts supporting west roof overhang.

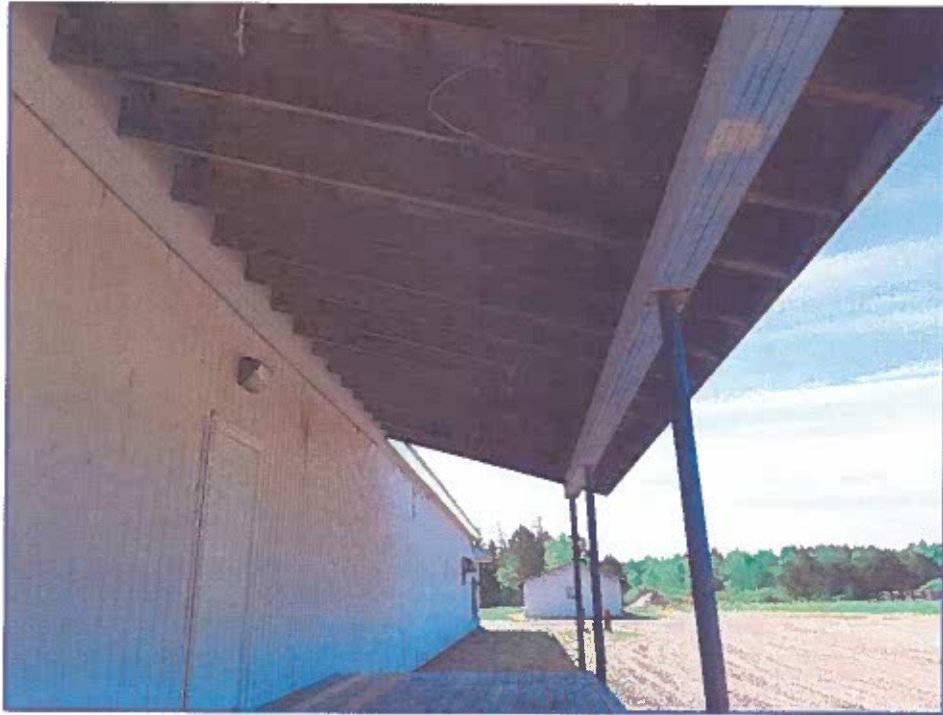
Photograph 15: No protection of west overhang steel posts. Leaving them susceptible to vehicle impact

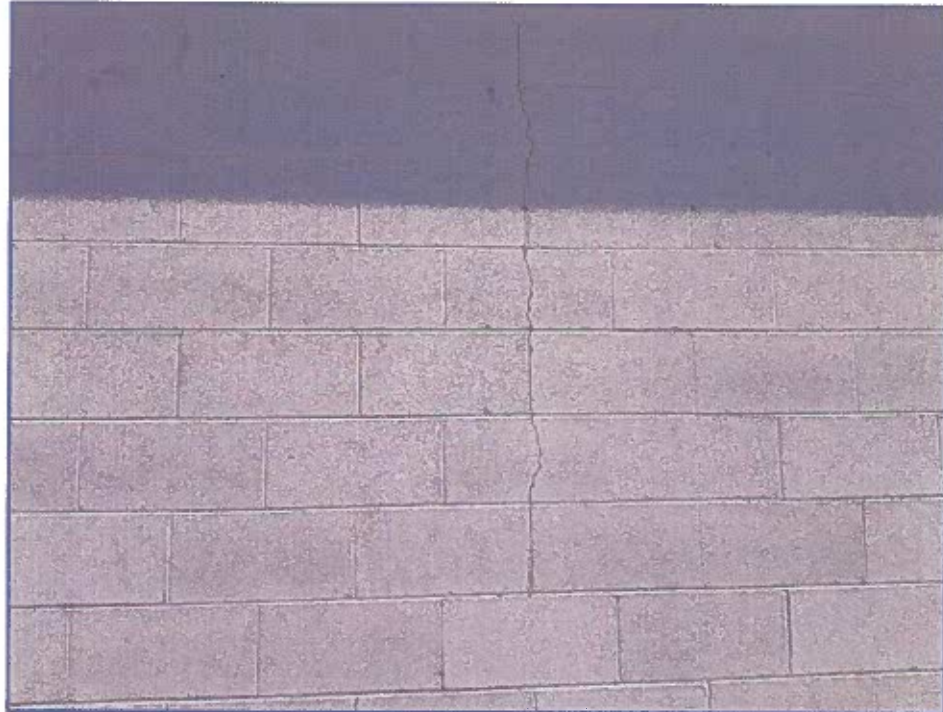
Photograph 16: Narrow vertical crack in south concrete block wall

10. Epoxy inject vertical crack in block wall
11. Repair damaged east wall and protect against moisture from vents above.

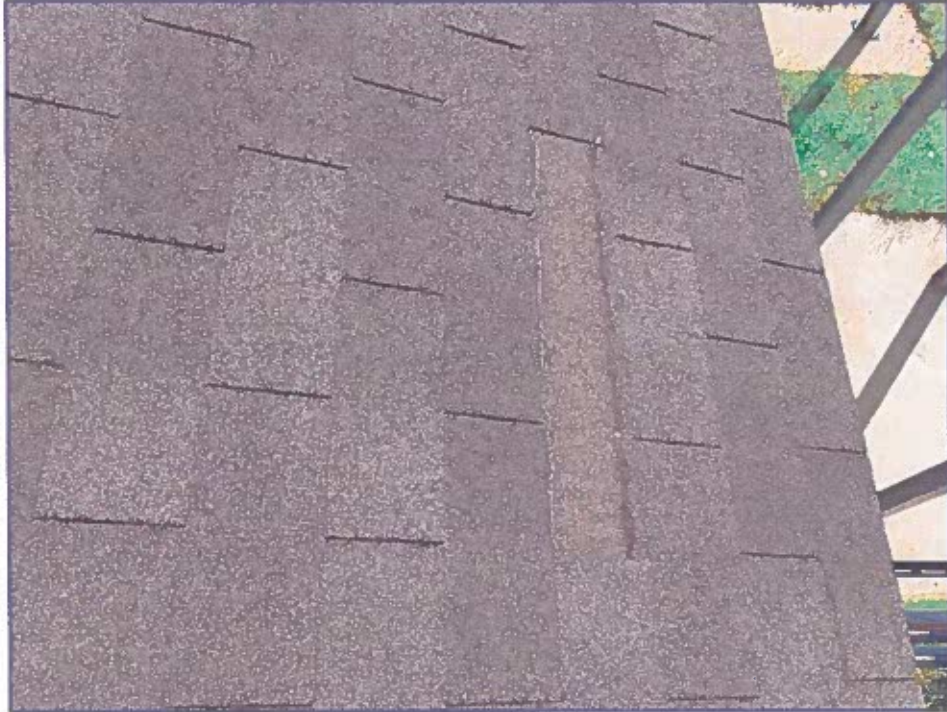
Photograph 17: Missing shingle on roof above Zamboni room

1. Repair all areas of roof where damage has occurred, including flashing and roof sheathing
2. Caulk all openings in exterior finishes including caulking of flashing from lower roof to gable end wall.

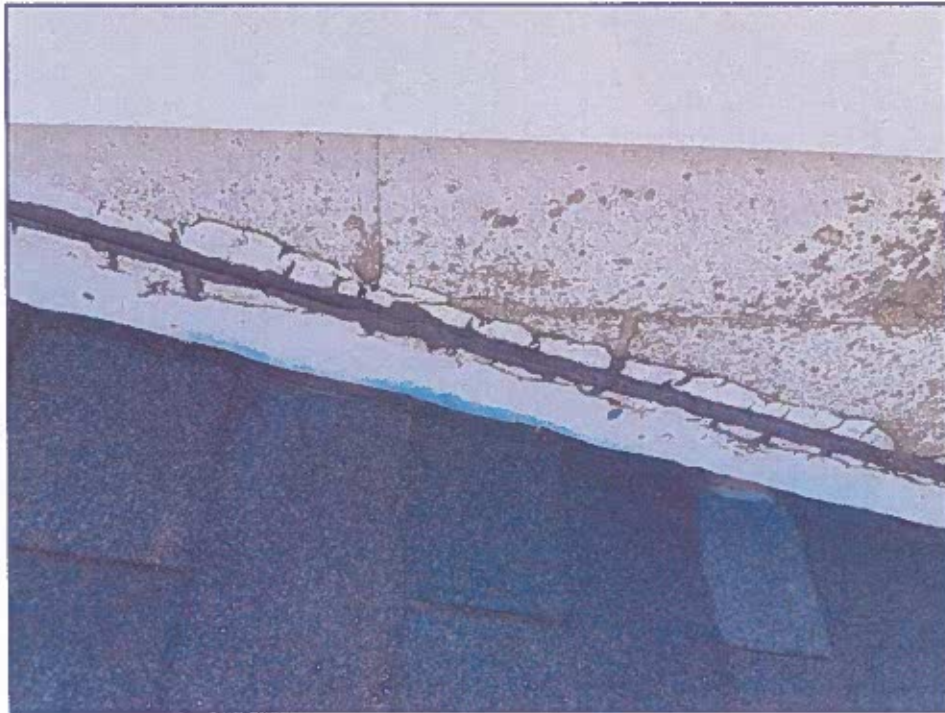
Photograph 18: Failing caulking throughout

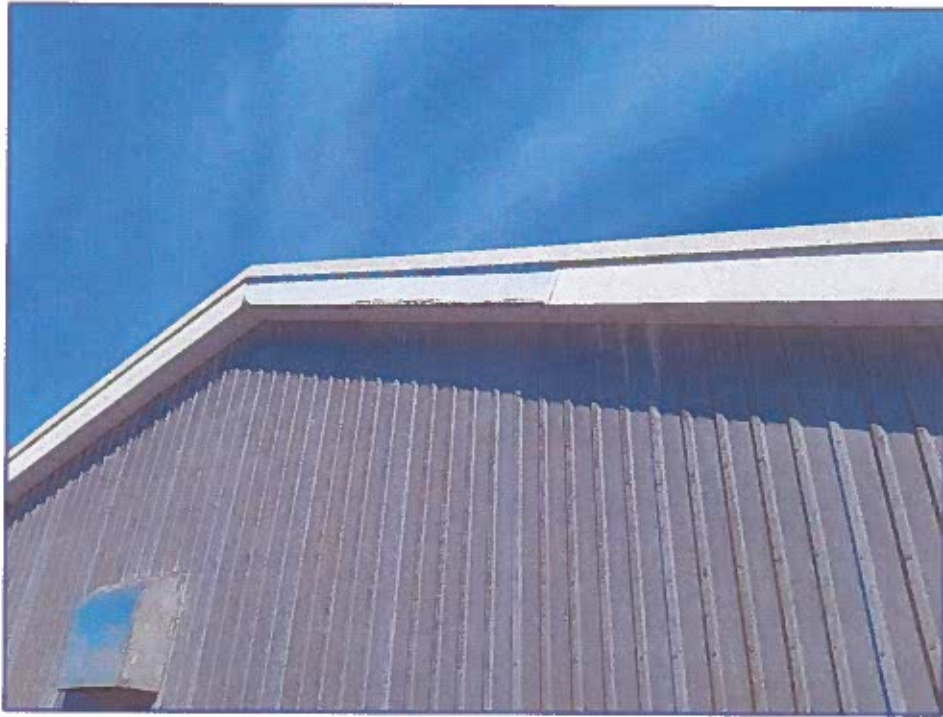
Photograph 19: Missing section of steel fascia on south face of roof

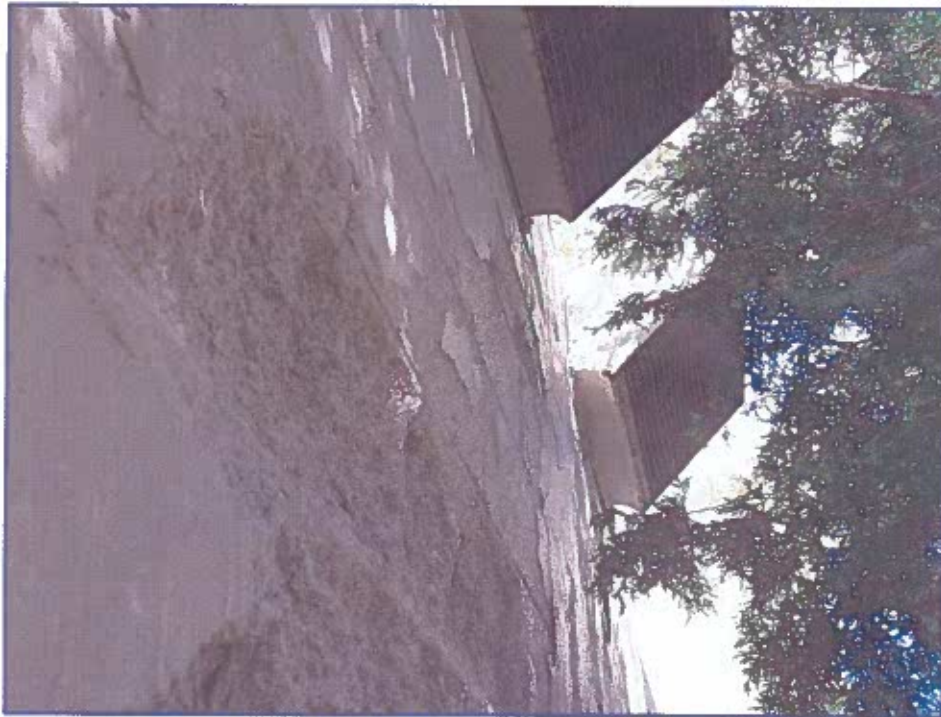
Photograph 20: deterioration of exterior block wall on east side of building as a result of moisture from vents above

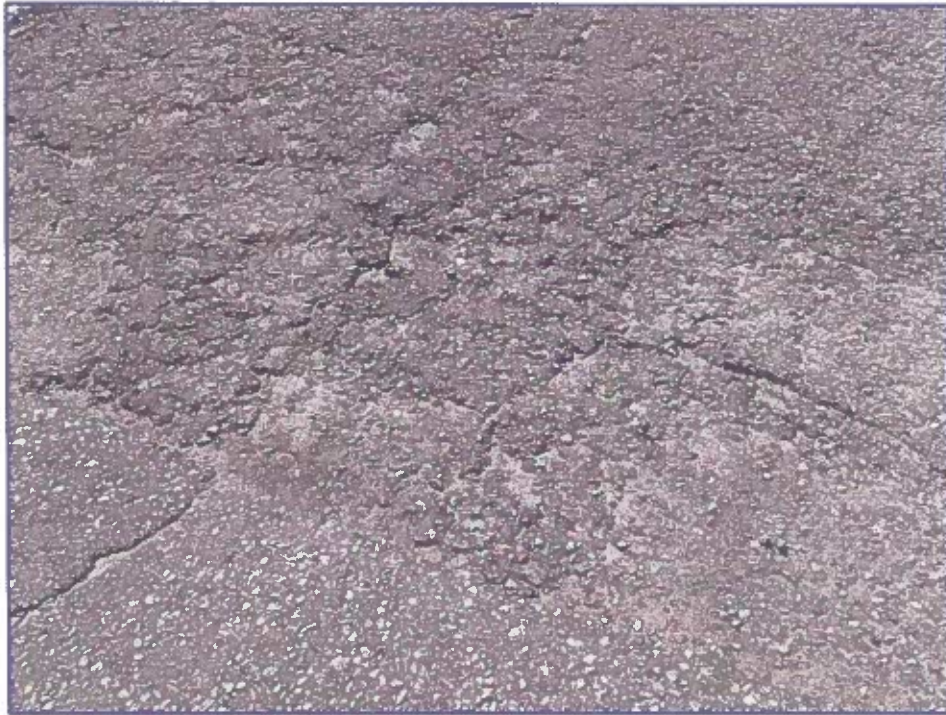
Photograph 21: Severely deteriorated asphalt at north side of site
