REQUEST FOR PROPOSAL NUMBER: 2020-04

BUILDING CONDITION ASSESSMENTS

POWASSAN SPORTPLEX BUILDING CONDITION ASSESSMENT

TSH PROJECT NO. 36-19660

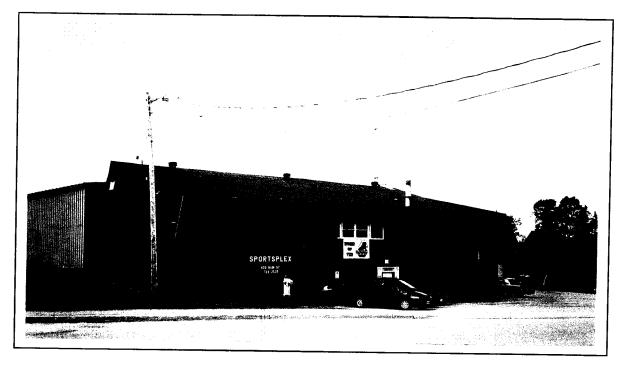
EAST ELEVATION

Note: General Condition

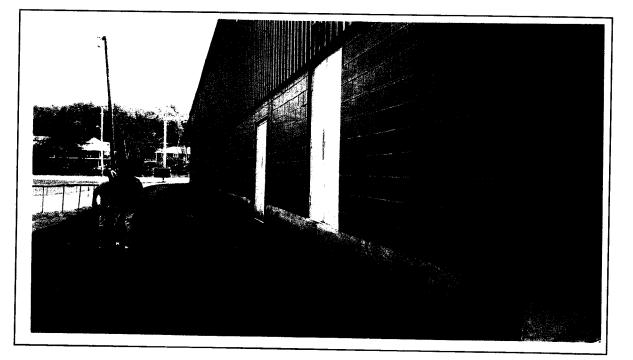
BUILDING	COMPONENT	P	REMARKS	REPAIR PRIORIT
Site	Asphalt	-	Asphalt areas appear to be in fair condition	
Foundation	Concrete		There is no evidence of any foundation settlements or	
	Block		detrimental movements.	
			Extensive moisture and unsightly algae growth along the north	1-2 years
			exterior foundation wall indicates a lack of perimeter	
			insulation. It is recommended that the exterior grades be	
			raised not only to eliminate the exposed walls but also to	
			reduce the step to the exit doors from the facility.	
Exterior	Metal Siding		The exterior metal siding is in fair to good condition.	
Walls			All wall penetrations should be properly sealed to prevent	Immediate
			moisture infiltration.	
	Masonry		Most of the painted exterior masonry was noted to be in good	
			condition.	
		٠	There is no evidence of settlement or movements with the	
			back up load bearing masonry block.	
		=	Parging in several areas is delaminated due to frost action.

NORTH ELEVATION Note: Condensation on foundation wall

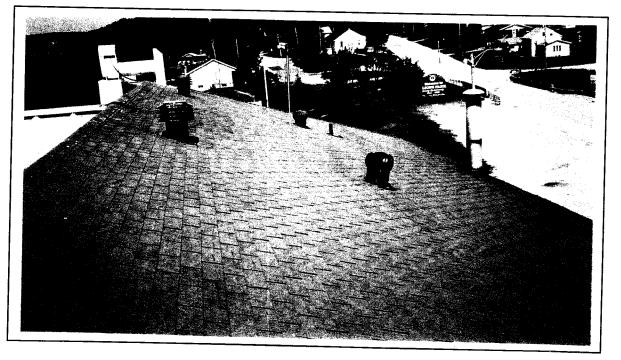
recommended that all fasteners be torqued and sealed to	
			prevent further corrosion and leakage. Refer to photo.	
	Roof		The existing foil faced batt insulation is in fair condition.	
	insulation	•	Significant corrosion was noted on the wire mesh used to	
			support the insulation. Painting of the wire mesh is	
			recommended as soon as possible for aesthetic reasons.	
	Shingles	•	The existing roofing shingles on the east end of the facility are	
			in fair condition. Significant deterioration was noted on local	
			areas of the roof near the chimney stack, eaves and ridge.	
			Refer to photos.

VIEW OF ROOF Note: Deterioration of shingles at ridge and eave

•	Replacement of local areas of shingles is recommended within	2-4 years
			2 to 4 years.	j
	Low Emissive		There is no low-Emissive ceiling in the facility.	
	Ceiling	•	The installation of a low E ceiling is recommended to reduce	
			the rate of deterioration and corrosion of the roof steel	
			elements.	
Grandstand	Pre-cast	•	There was no significant deterioration or distress apparent on	
	Concrete		the viewing area support slabs and support framing.

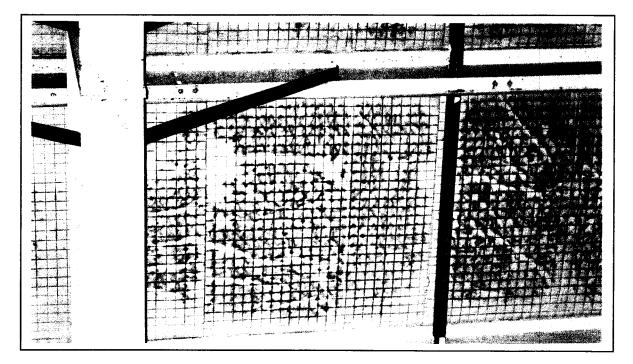
VIEW OR ARENA ROOF DECK

Note: Corrosion of wire mesh

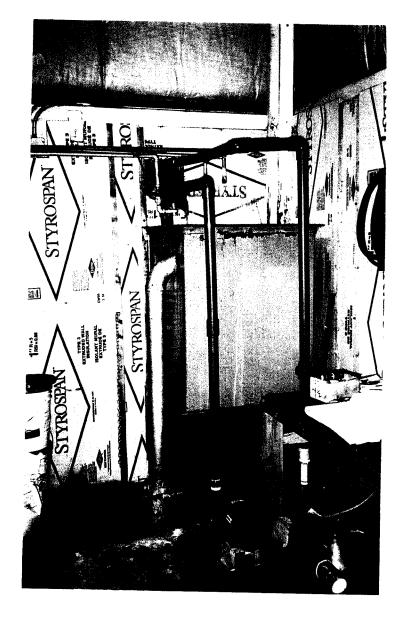
INTERIOR VIEW OF REFRIGERATION ROOM Note: Exposed wall insulation
