2024 Powassan Building Assessments

**TROUT CREEK COMMUNITY CENTRE
181 MAIN STREET WEST, POWASSAN**

Municipality of Powassan

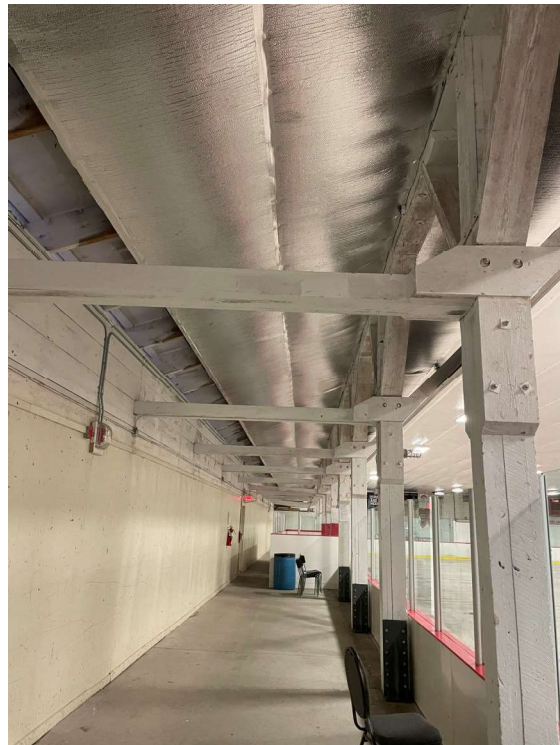
Tatham Engineering Limited (Tatham) was retained to perform a Building Assessment of the Trout Creek Community Center, located at 181 Main Street West in Powassan. We visited the site in April, 2024 and spoke with Public Works Foreman, Trevor Tenant to identify any areas of concern and provide details on operating procedures. An overall photograph of the building has been included as Photograph 1.1 in Appendix A.

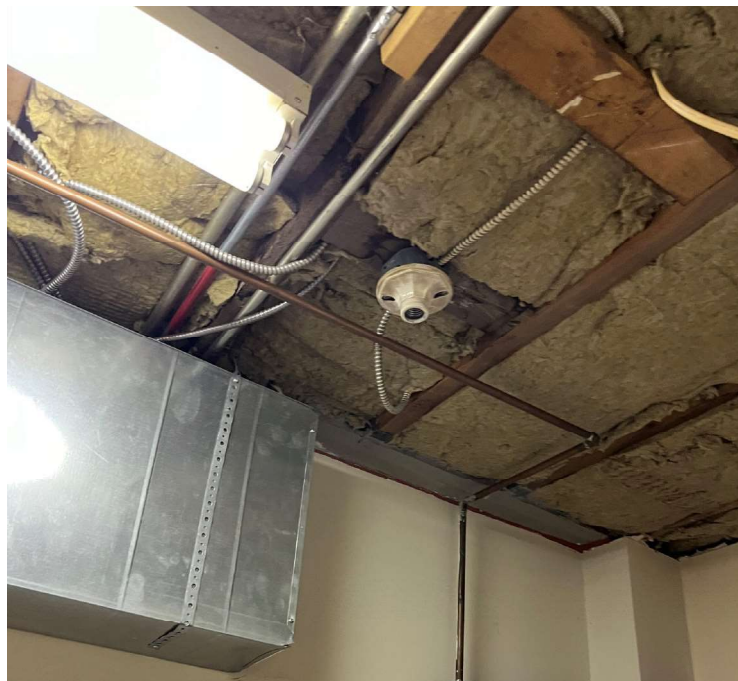
Photograph 3.2.1

1. Interior lighting fluorescent tube luminaires have multiple units without housing covers which may be a concern if the fluorescent tube is damaged (Photograph 3.2.1). Replace existing cover wraps for wrap around luminaires.
2. There is a missing lightbulb (Photograph 3.2.2). Install a replacement bulb.
3. There is wiring in the electrical room appears to be damaged (Photograph 3.2.3). Replacement of this wiring is recommended.
4. Fuse panels should be upgraded to breaker panels (Photograph 3.2.4).
5. A disconnect is required for refrigeration units for the walk-in refrigerator (Photograph 3.2.5).
6. A junction box was found without cover plate. Install one as per code requirements (Photograph 3.2.6).
